LEVEL 2 REPLACEMENT RESERVE REPORT FY 2026 SHIPLEYS CROSSING HOA

SHIPLEYS CROSSING HOA

MILLERSVILLE, MARYLAND

April 23, 2025

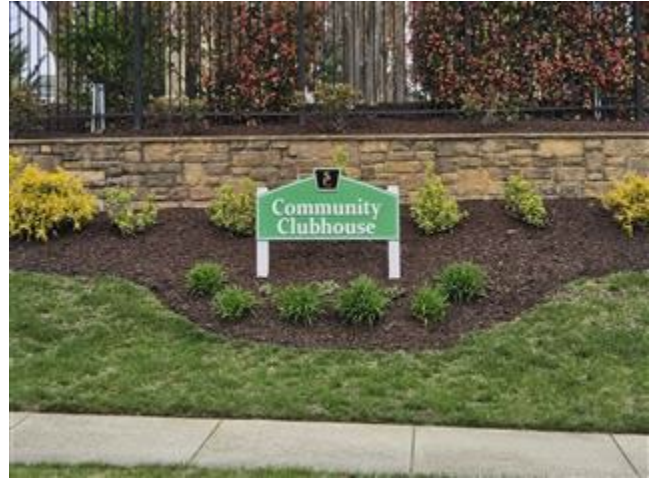
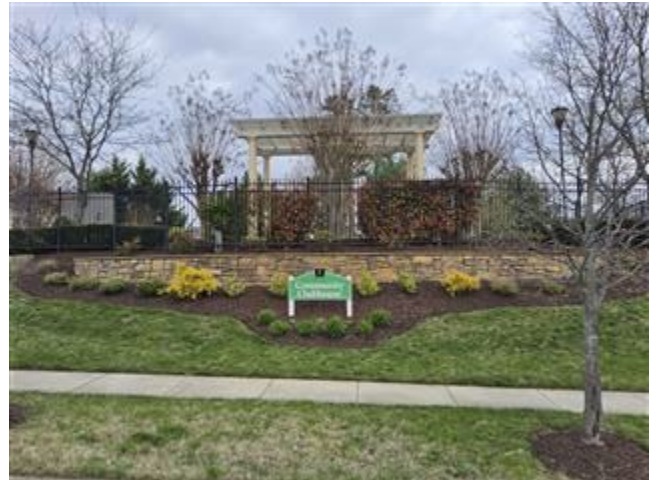
Retaining Walls. The Association maintains a masonry stone retaining wall south of the clubhouse swimming pool. The retaining wall appears to be in good condition with no noticeable leaning, bowing, and deterioration.

Please note that MillerDodson did not conduct a structural evaluation of the retaining wall. Such an evaluation is beyond the Scope of this Reserve Study. MillerDodson strongly recommends that the Association retain the services of a Structural Engineer/Geotechnical Engineer to conduct thorough and periodic evaluations of retaining walls.

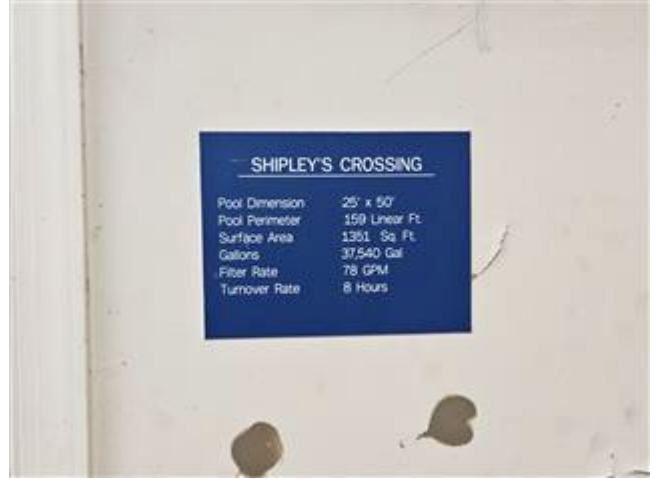
- Coping. The pool is edged with masonry brick coping. The coping is reported to be in good condition. The pool was winterized with the cover over the pool at the time of the assessment.
- Pump and Filter System. The filter system appears and is reported to be in good operating condition but was not in operation due to winterization of the pool.
- Pool Fence. The pool is enclosed by a metal picket fence that is in good condition.

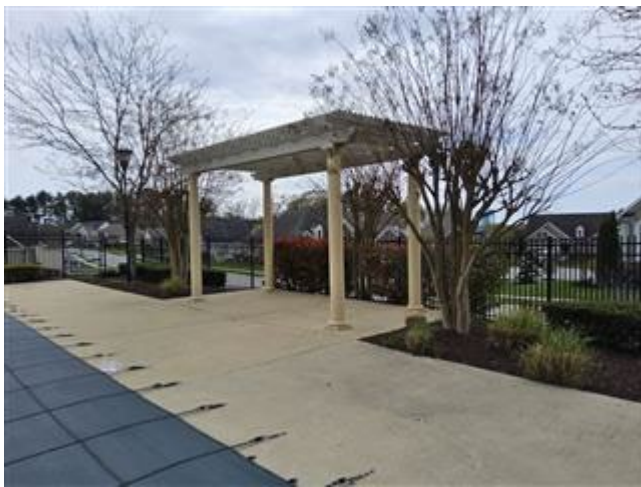
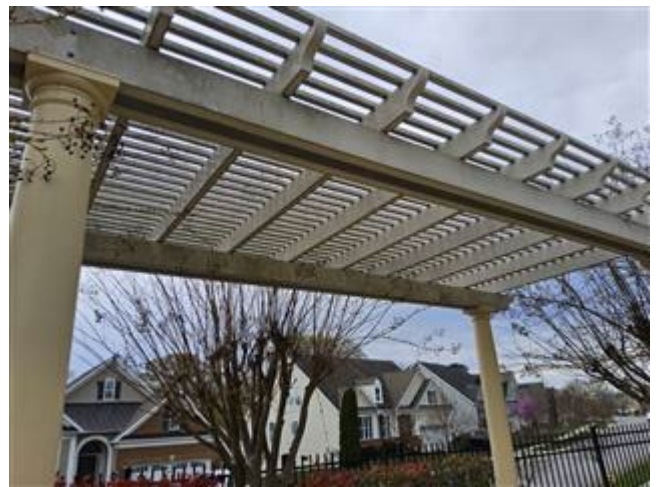
Clubhouse Swimming Pool Pergola. The swimming pool has an adjacent pergola of approximately 220 sf. This pergola is made of wood and supported by four PermaCast columns. The pergola is in good condition.

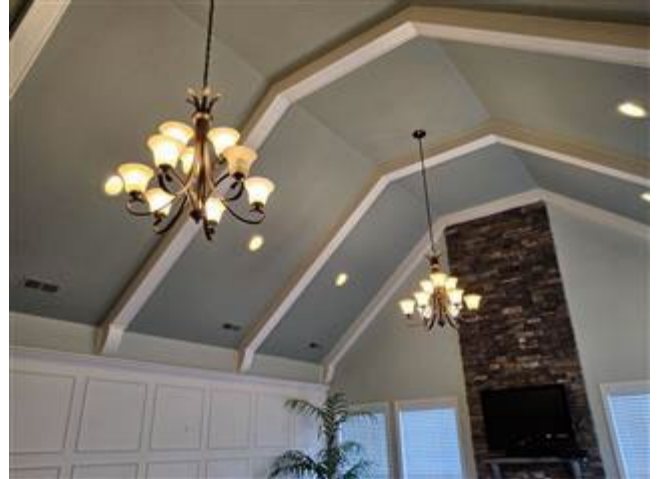
Can Lights with LED Fixtures and Chandelier Lights in the Main Room. Throughout the building there are 31 can lights with LED lamps. These fixtures provide the main lighting for main room, card room, shower stalls, lobby and hallway. These lights are all operational and appear to be in good condition. Additionally, the main room of the clubhouse has two large chandeliers which provide light for the room. These lights are in good condition and are fully operational.

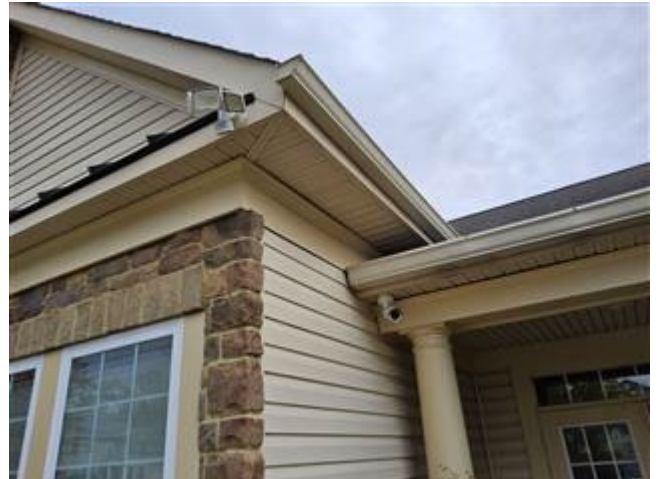
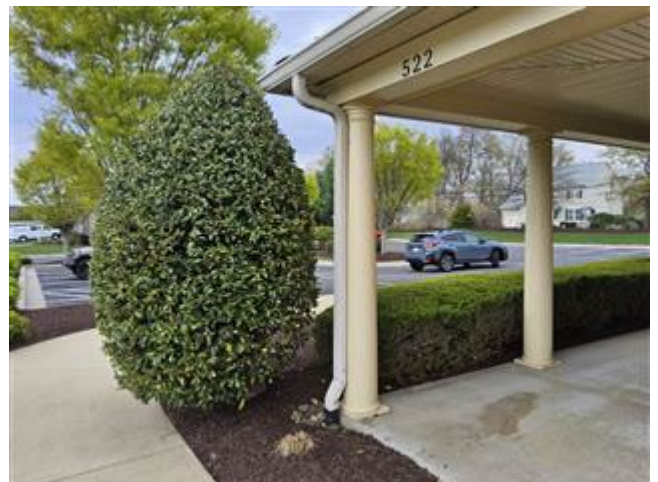
Gutters and Downspouts. The clubhouse has aluminum gutters and downspouts. The gutters and downspouts appear to be in good condition. The downspouts are attached to an underground drain system which effectively transports rain water away from the foundation.

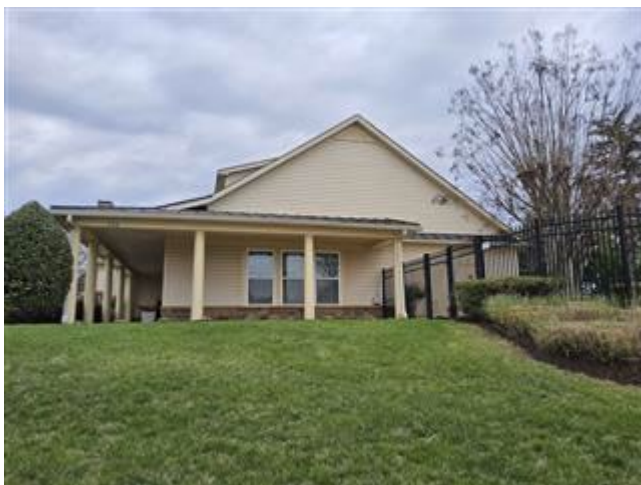
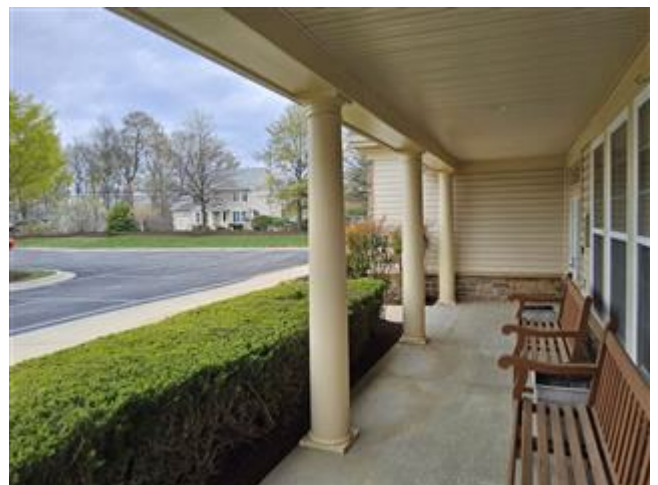
Clubhouse PermaCast Porch Columns. The front porch of the clubhouse has eight permacast columns which support the roof of the building. The columns are in good condition.

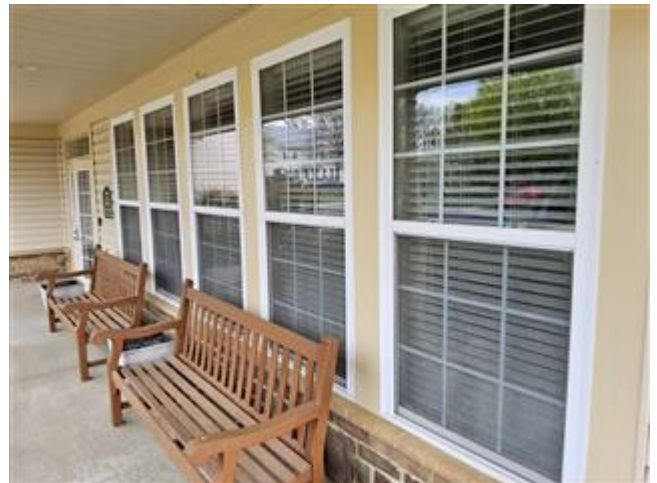
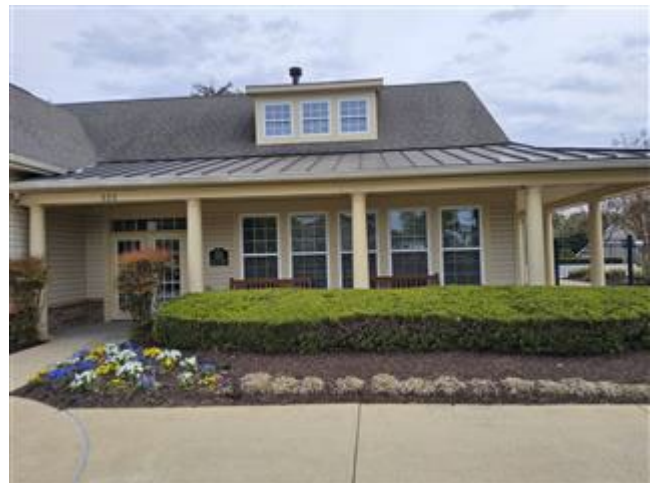
Fiberglass Windows, Double Hung. The building has 17 windows on the first floor which are 3 ft x 6 ft and 5 dormer windows which are approximately 3 ft x 3 ft. These windows are in good condition.

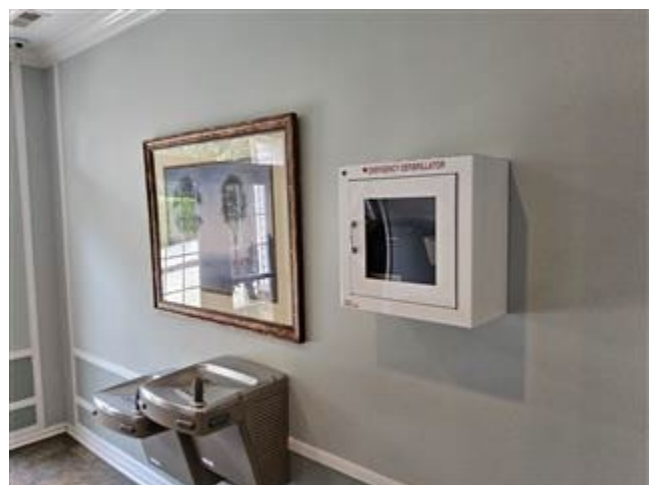
AED Pack. The Association is responsible for the AED which is located in the clubhouse foyer. This piece of equipment appears to be in good condition and ready to respond to a cardiac incident.

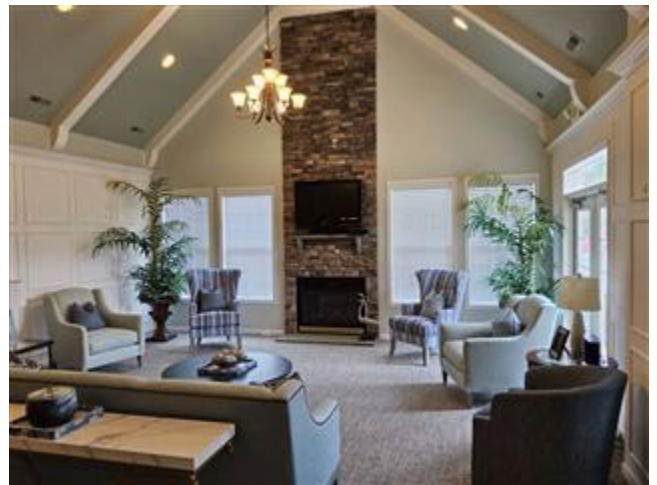
Gas Fireplace in Main Room. The clubhouse's main room has a masonry chimney structure for the gas ventless fireplace. Although not seen in operation, this natural gas fire place appears to be in good condition.

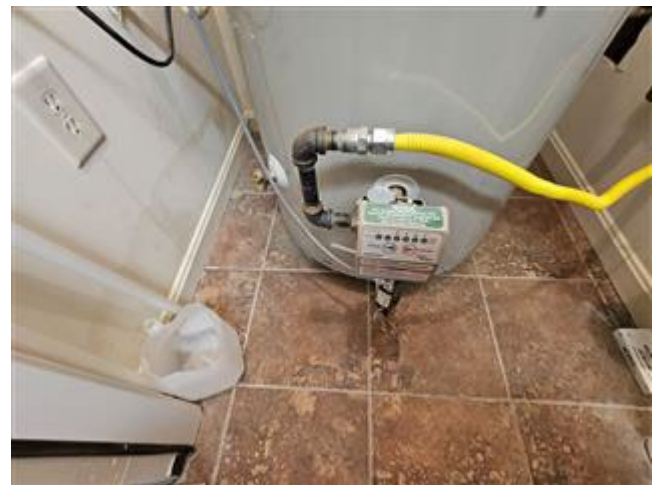
Natural Gas Water Heater, 74 Gallon. The clubhouse has a 74-gallon natural gas water heater to support the shower rooms and the rest of the clubhouse operations. The water heater is located in the men's shower room. From the serial number the water heater was manufactured in May 2008 and is 16-years old.

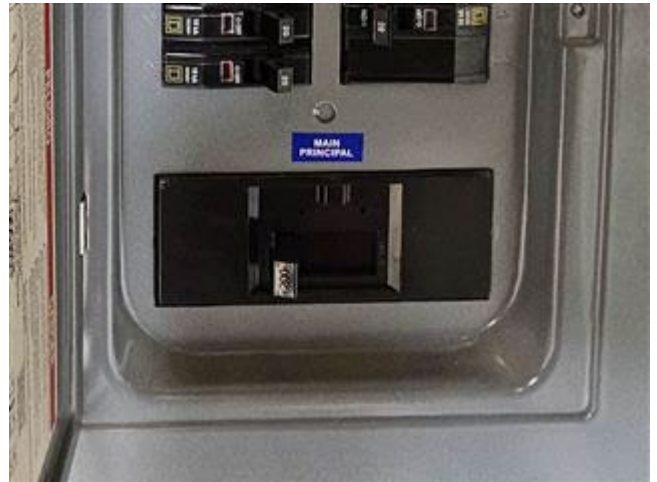
Electrical Distribution Panels. The clubhouse has three electrical distribution panels rated at 200-amp, 120/240-volt each. These panels have a 50-year service-life and are in good condition.

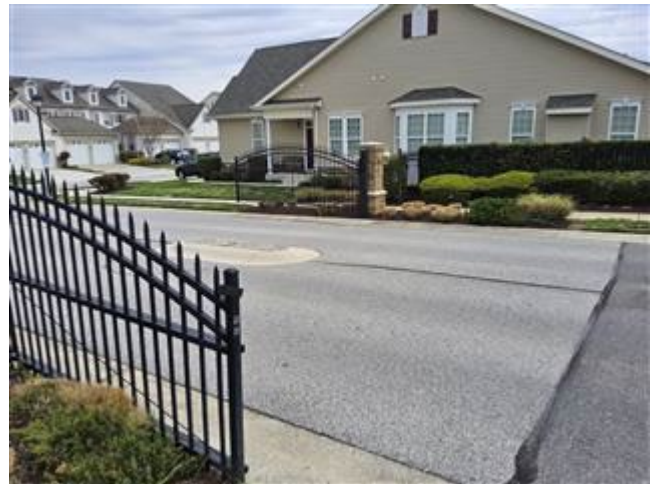
Vehicle Swing Gate. The north community access point has a black powder coated metal swing gate that does not currently have a vehicle access system or power installed. The conduit for the access system appears to be in place, but the gate also appears to be only manually operated. We understand that there are no plans to operate the community as a gated community. In the future if the community wishes to be a gated-community it will need to fund this modification with other than reserve funding.. The gate is attached to two smaller masonry piers with carriage lights. The gate appears to be operational and is in good condition.

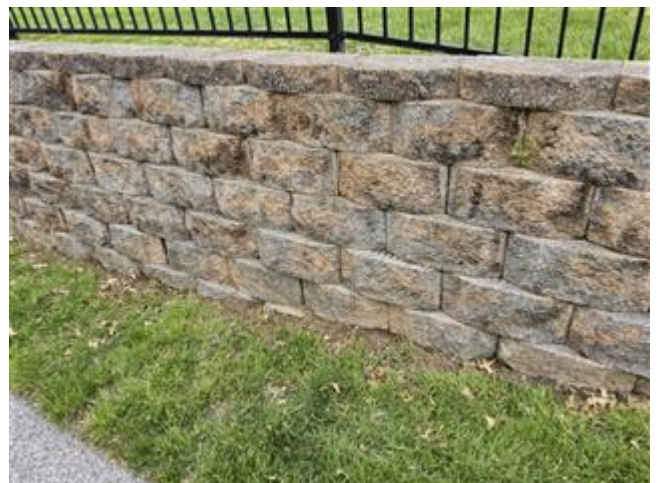
Retaining Walls. The Association maintains six segmented block retaining retaining walls. The retaining walls appear to be in good condition as no leaning, displacement, bowing, or movement observed.

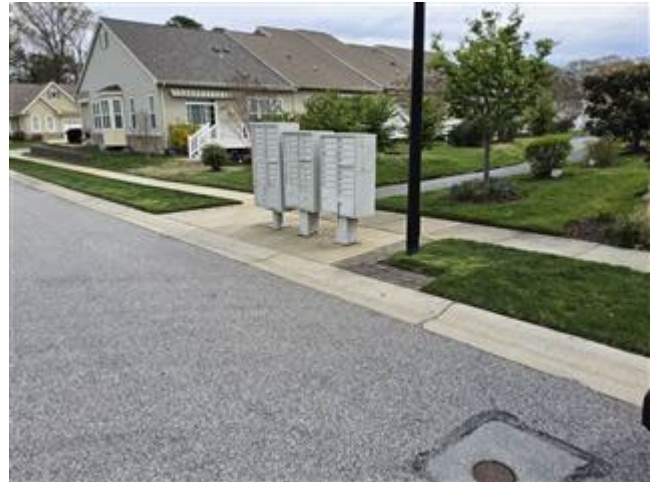
Mailboxes. The North Shipley's Crossing Community has five cluster mailboxes located throughout the community. These mailboxes appear to be in good condition.
