LEVEL 2 REPLACEMENT RESERVE REPORT FY 2026 SHIPLEYS CROSSING HOA

SHIPLEYS CROSSING HOA

MILLERSVILLE, MARYLAND

April 23, 2025

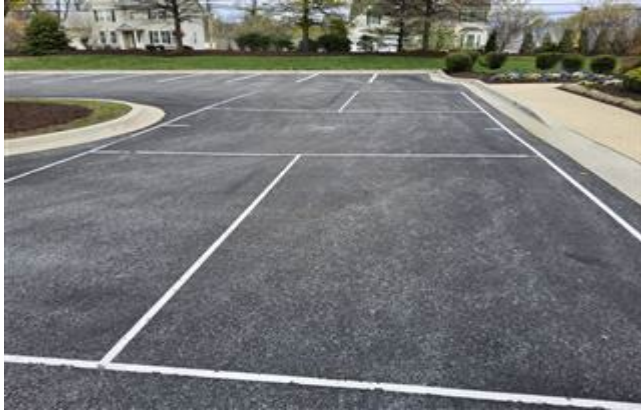
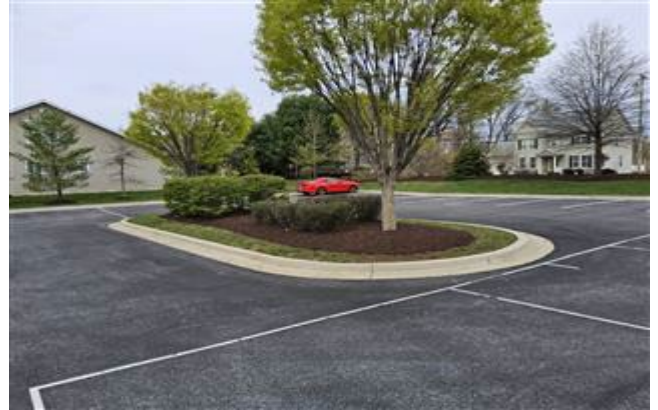
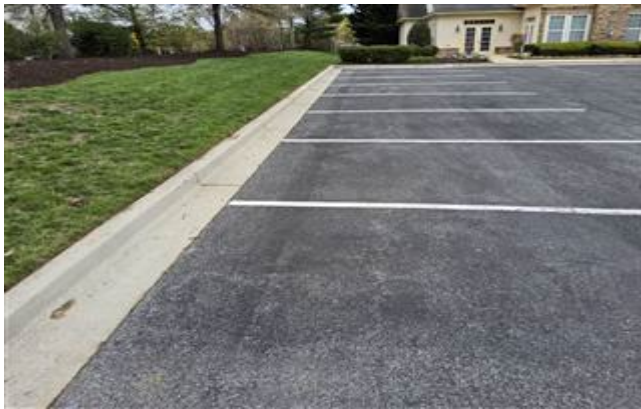
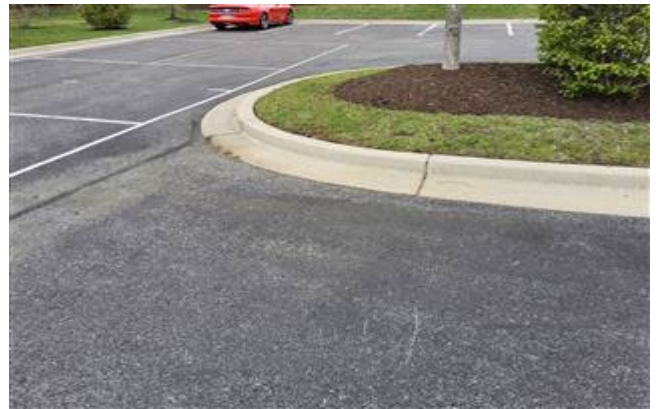
For seal coating, several different products are available. The older, more traditional seal coating product is paint. They coat the surface of the asphalt, and they are minimally effective. However, the newer coating materials, such as those from Total Asphalt Management and Asphalt Restoration Technologies, Inc, are penetrating. They are engineered to 're-moisturize' the pavement. Asphalt pavement is intended to be flexible. Over time, the volatile chemicals in the pavement dry, the pavement becomes brittle, and degradation follows as cracking and potholes. Re-moisturizing the pavement can return its flexibility and extend pavement life.

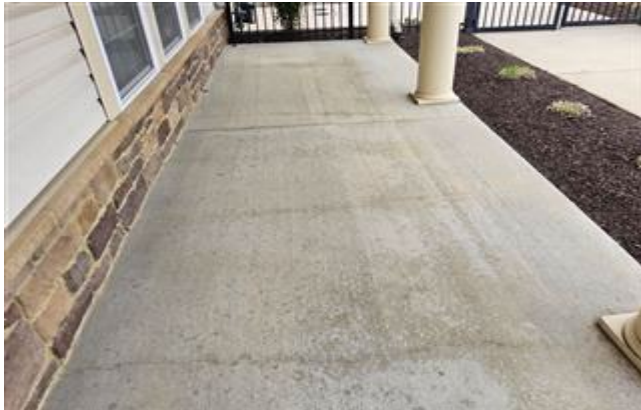
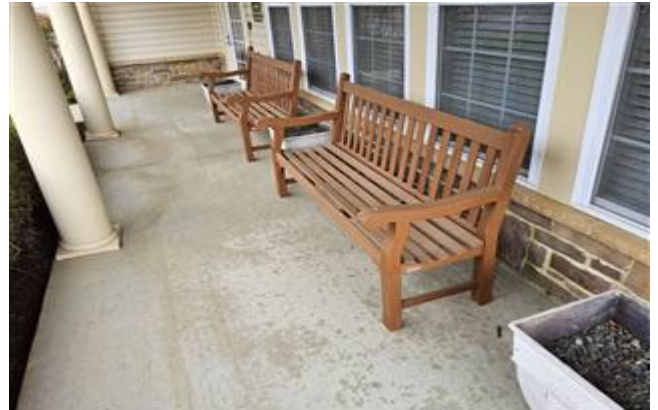
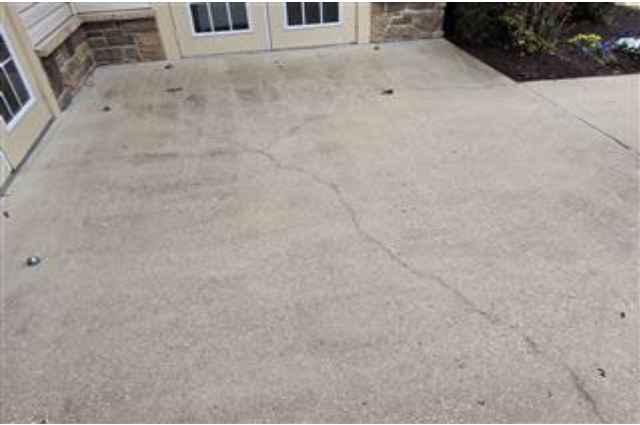
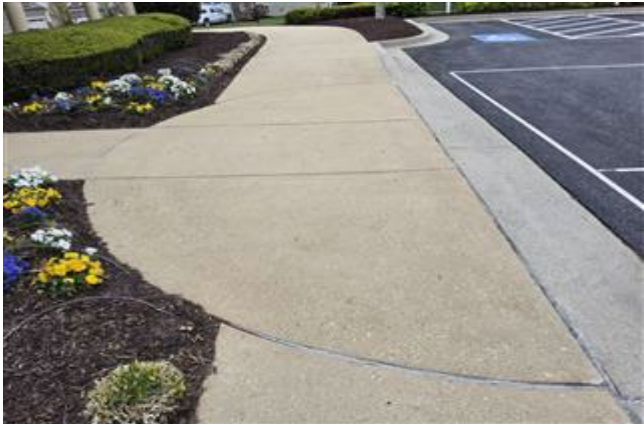
Clubhouse Front Patio and Sidewalks

Concrete Work. The concrete work includes the community clubhouse's sidewalks patios, swimming and party area deck, curbs, and gutters as well as other flat work. We have modeled for curb replacement when the asphalt pavement is overlaid. The overall condition of the concrete work appears to be in good condition with cracks starting to be observable.

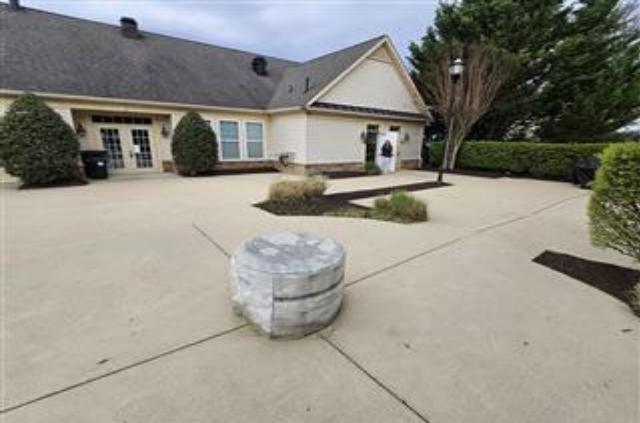
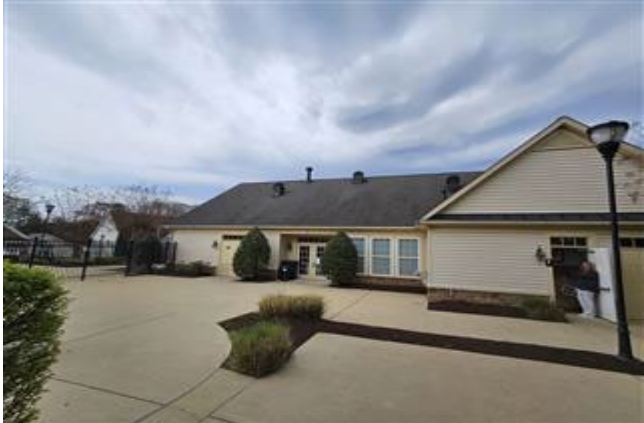
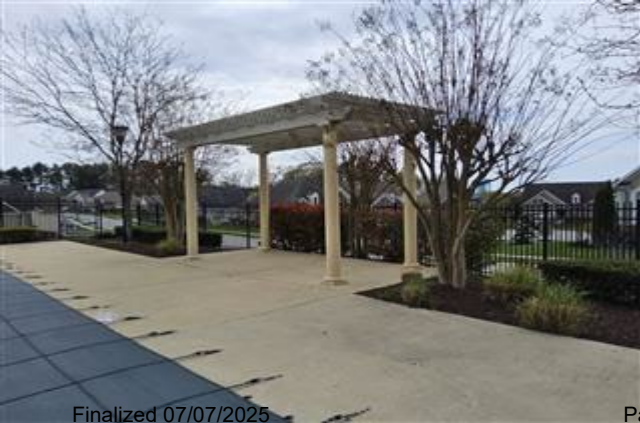
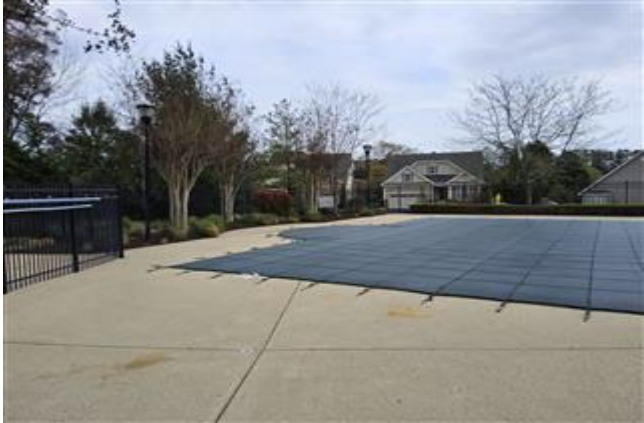
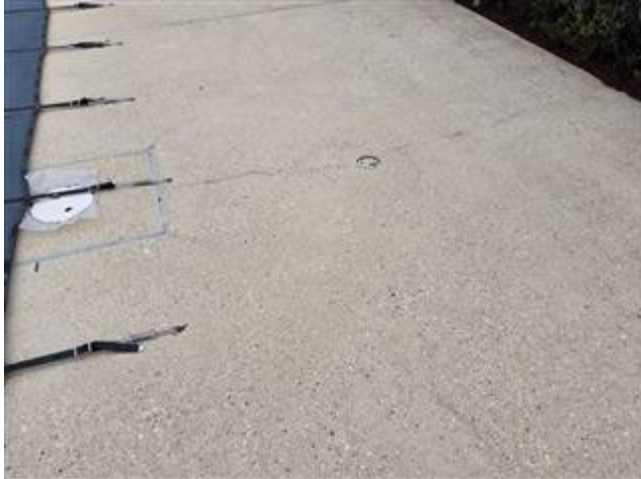
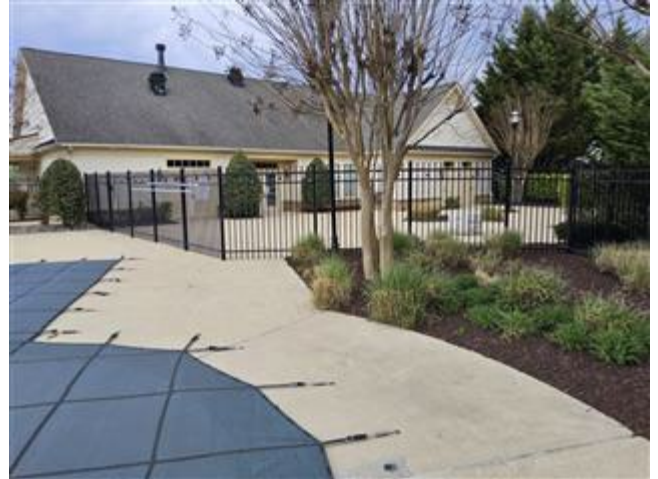
Concrete Pool/Party Area Deck

- **Pool Shell.** The shell for the swimming pool is reported to be in good condition. The pool was winterized with the cover over the pool at the time of the assessment.
- **Pool Deck.** The pool has a concrete deck with drains, and the overall condition of the deck appears to be in good condition with minor cracking and minimal tripping hazards. (Condition pictures are included in Concrete Flatwork Section)
- **Whitecoat.** The pool whitecoat is reported to be in good condition. We have assumed eight to ten years of service life for the pool whitecoat. The pool was winterized with the cover over the pool at the time of the assessment.
- **Waterline Tile.** The waterline tile is reported to be in good condition. We have assumed the waterline tile will be replaced or restored when the pool is whitecoated.

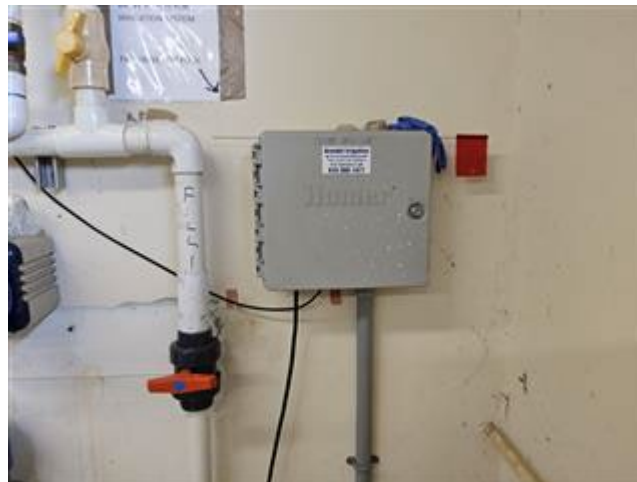
Irrigation Controllers. A discussion was held with the irrigation maintenance contractor regarding the irrigation system. The system has four controllers and four backflow preventers. The replacement of sprinkler system water lines and sprinkler heads is considered maintenance funded vice reserve funded. The clubhouse's controller is located in the pool equipment room and appears to be operational and in good condition.

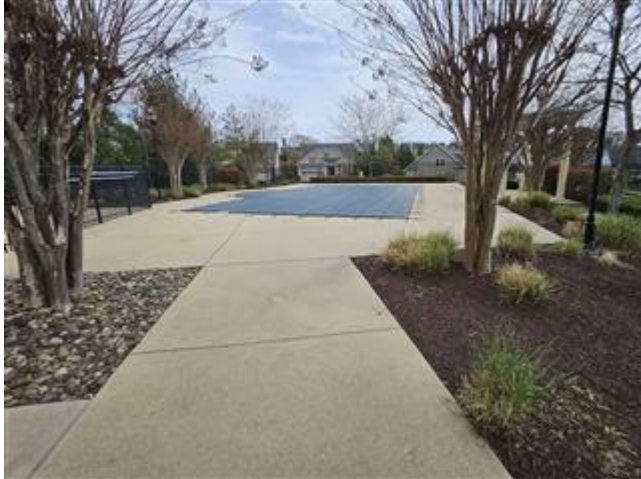
Swimming Pool. The community operates an outdoor pool of concrete construction. The pool was winterized at the time of the site visit and is reported to be in good condition. Listed below are the major components of the pool facilities:

- Coping. The pool is edged with masonry brick coping. The coping is reported to be in good condition. The pool was winterized with the cover over the pool at the time of the assessment.
- Pump and Filter System. The filter system appears and is reported to be in good operating condition but was not in operation due to winterization of the pool.
- Pool Fence. The pool is enclosed by a metal picket fence that is in good condition.

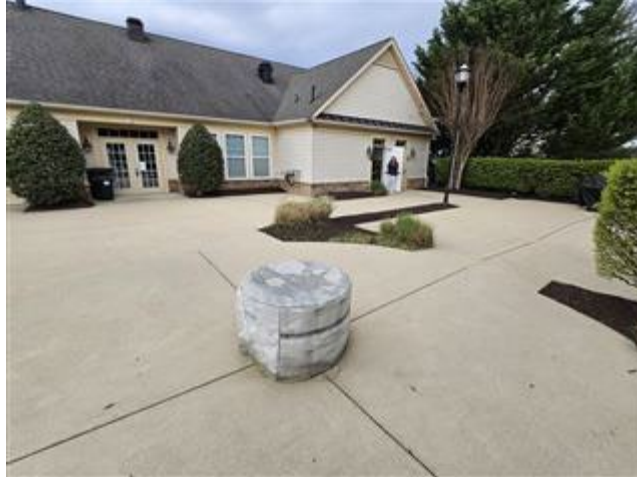
Gas Fire Pit. The party area behind the club house has a gas fire pit that was winterized but appears to be in good condition.

- Annual Professional Inspection
 - Schedule a Professional Check-Up: Have a professional inspect your fire pit at least once a year to ensure all components are in good working order and to address any potential issues.

- Seasonal Maintenance:
 - Winter Preparation: Before winter, clean the fire pit thoroughly and cover it to protect it from harsh weather.
 - Spring Check-Up: In spring, inspect the fire pit for any damage that may have occurred over the winter and perform any necessary maintenance.

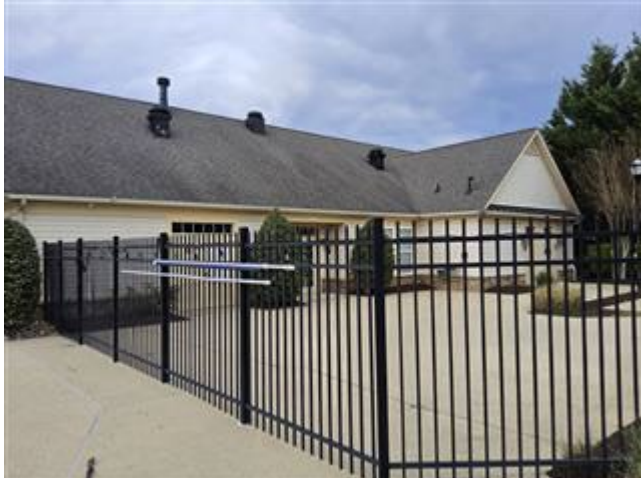
Swimming Pool Fence (Aluminum, Three Rail, Stake, 6' High)

Swimming Pool Decorative Aluminum Fencing. The Association maintains decorative aluminum fencing around the swimming pool and party area that are in good condition. Fencing systems have a large number of configurations and finishes that can usually be repaired as a maintenance activity by replacing individual components as they become damaged or weathered.

Protection from weed trimmer string during lawn maintenance can extend the useful life of some fence types. Protection from this type of damage is typically provided by applying herbicides around post bases or installing protective sheathing.

Fence posts can have an extended useful life if these simple maintenance activities are performed. If left unattended, the pressure from expansive post rust can crack and damage the supporting material.

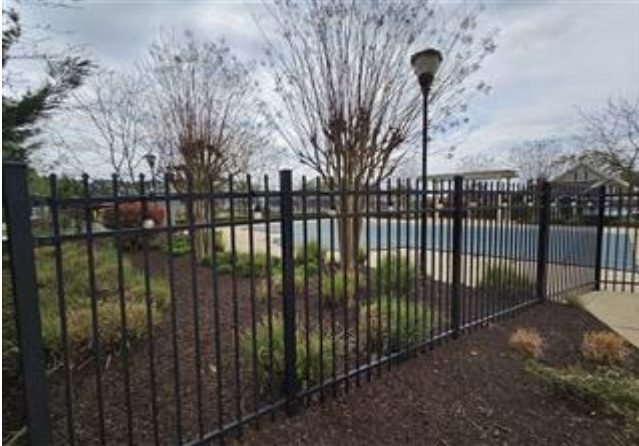
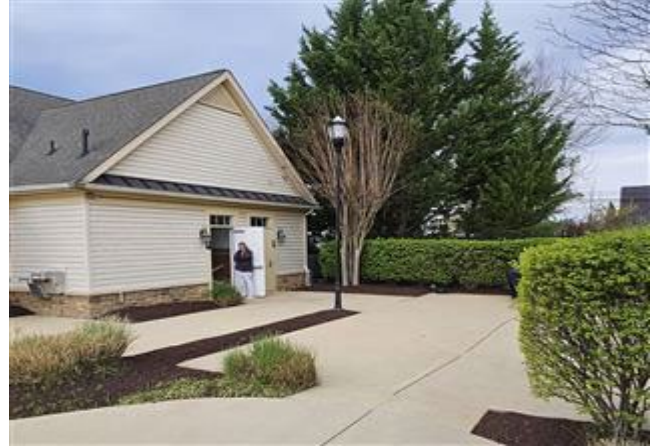
Site Lighting. The Association is responsible for the operation of the clubhouse's swimming pool and outdoor party deck lighting which consists of five light poles and fixtures which appears and is reported to be in good condition. The lights were not on at the time of our site visit, but we understand they are in operating condition.

This study assumes the replacement of the light fixtures every 15 to 20 years and pole replacement every 40 years. We assume that the underground wiring will also be replaced along with the light pole. When a whole-scale lighting replacement project is called for, we recommend consulting with a lighting design expert, as many municipalities have design codes, guidelines, and restrictions regarding exterior illumination. New technology, such as LED and LIFI, among others, should be considered along with factors such as environmental sustainability, longevity, and cost when they look at lighting replacement.

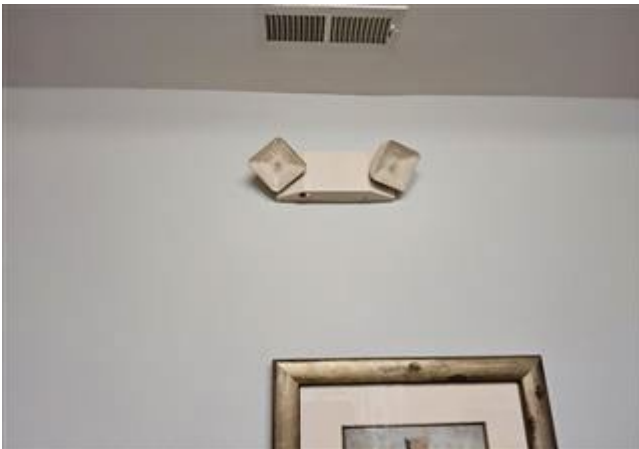
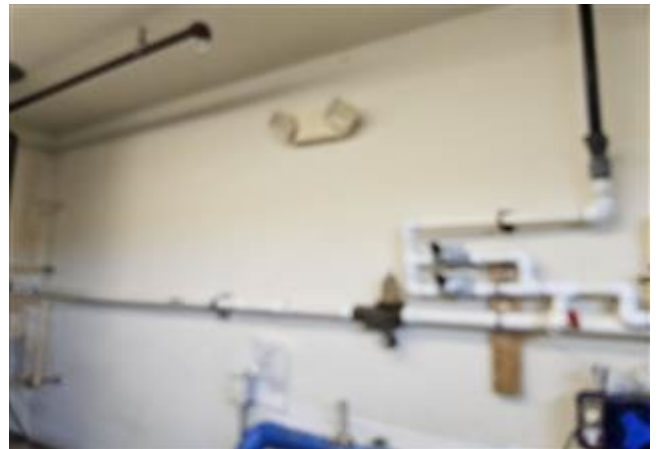
Emergency Light Fixtures. The building uses battery-powered light fixtures for emergency lighting in the event of a power outage. The fixtures are equipped with LED light sources. The fixtures appear to be in Good condition. Fixtures of this type have a typical service life of 20 years.

Emergency light fixtures are required on an irregular and infrequent basis. Frequently, fixtures fail to operate due to failed components that have gone unnoticed. Therefore, we recommend that the Association have all emergency light fixtures tested regularly every 3 to 6 months.

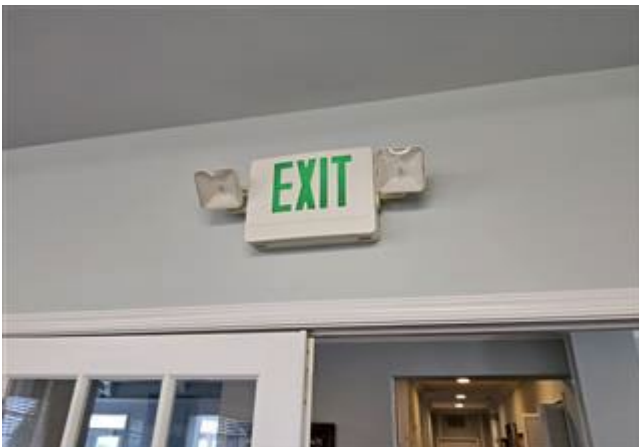
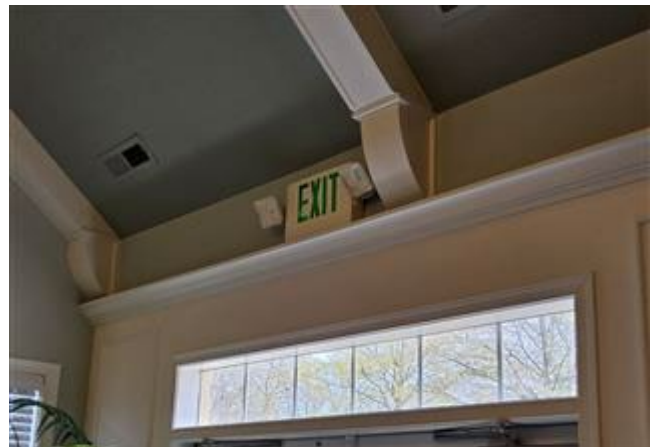
Exit Lights. The building uses illuminated exit lights with emergency lights at each exit. The exit lights use LED light sources. The general condition of the building's exit lights appears to be in good condition.

Every occupied room has an exit light and emergency light in place.

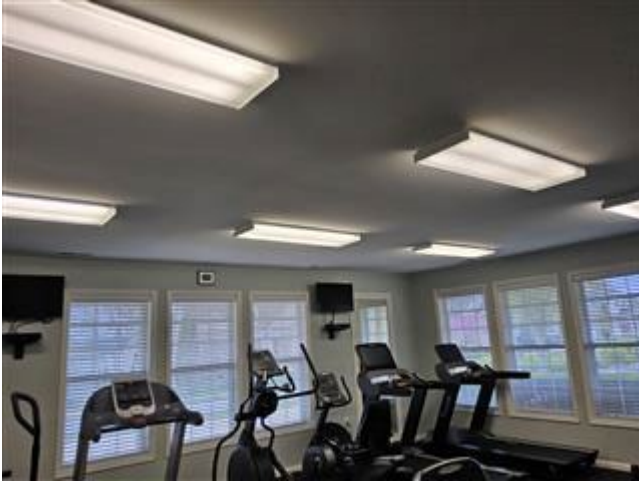
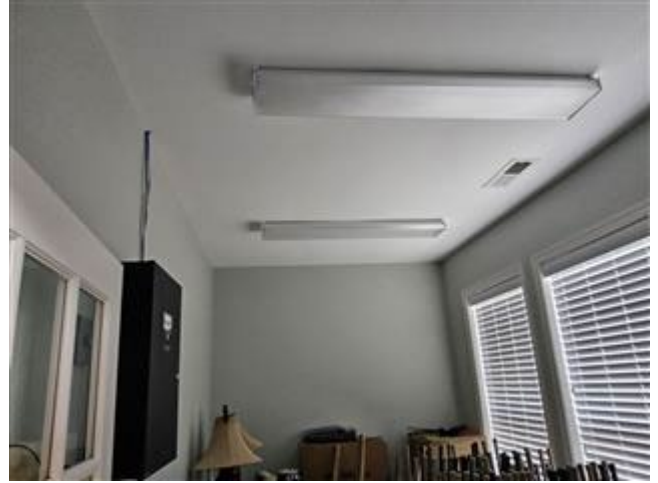
Fitness Room, Kitchen, and Storeroom.

Fluorescent Light Fixtures. The clubhouse has numerous fluorescent light fixtures throughout the facility. These fixtures are operational and in good condition. The Association should consider changing these light fixtures to LED fixtures when replacement is required due to the cost savings and environmental issues with fluorescent lights.

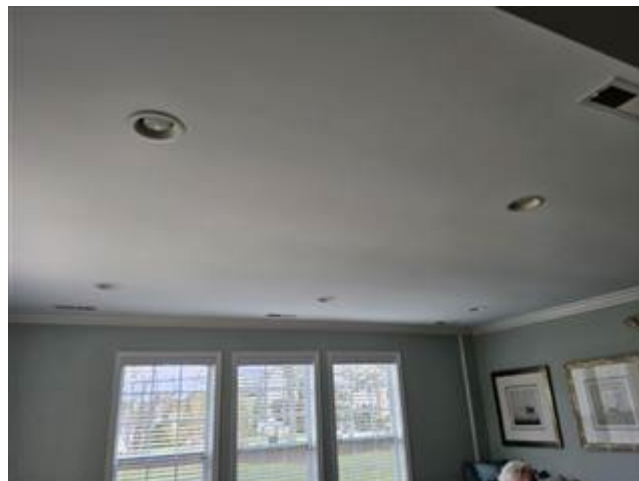
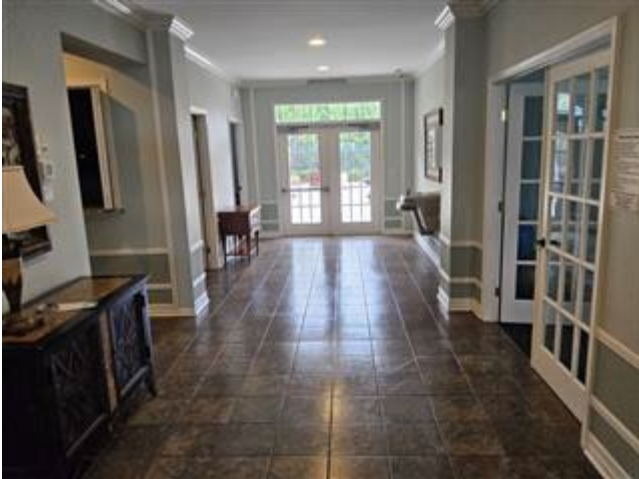
Can Lights with LED Fixtures and Chandelier Lights in the Main Room. Throughout the building there are 31 can lights with LED lamps. These fixtures provide the main lighting for main room, card room, shower stalls, lobby and hallway. These lights are all operational and appear to be in good condition. Additionally, the main room of the clubhouse has two large chandeliers which provide light for the room. These lights are in good condition and are fully operational.

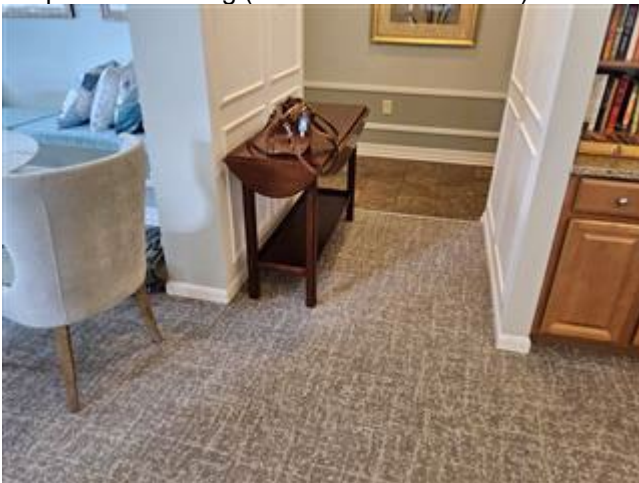
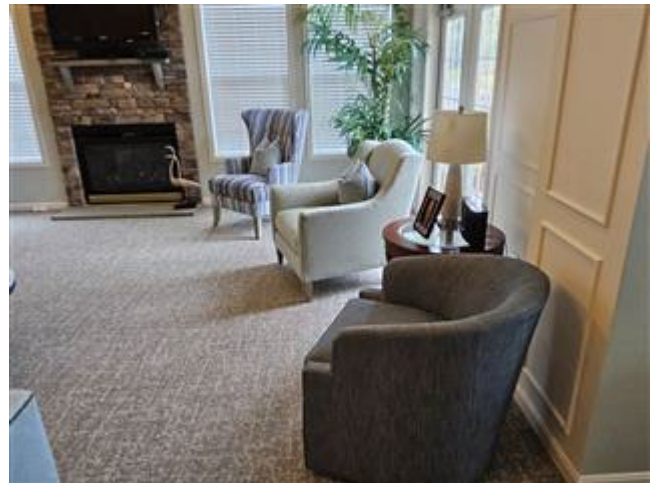
Carpet Tile Flooring (Main and Card Rooms).

Clubhouse Flooring. The clubhouse has flooring consisting of carpet tile for the main room and card room which is in good condition. The kitchen, lobby, storeroom, shower rooms and foyer all have ceramic tile floors which are also in good condition, and appear to have been placed within the past few years. The exercise room has rubber flooring which provides good footing and cushioning of weight equipment. This rubber flooring is in good condition.

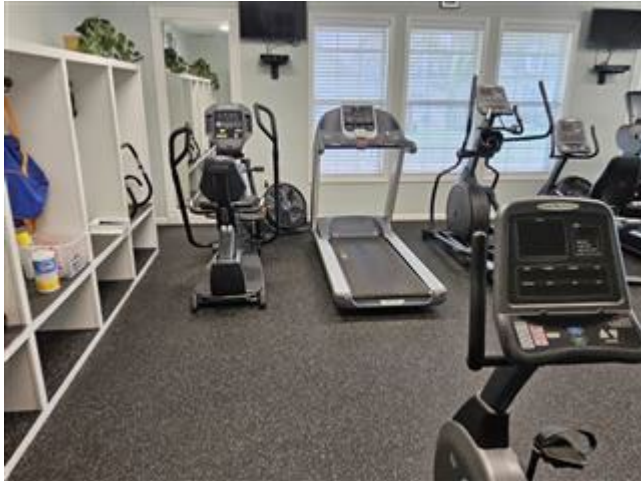
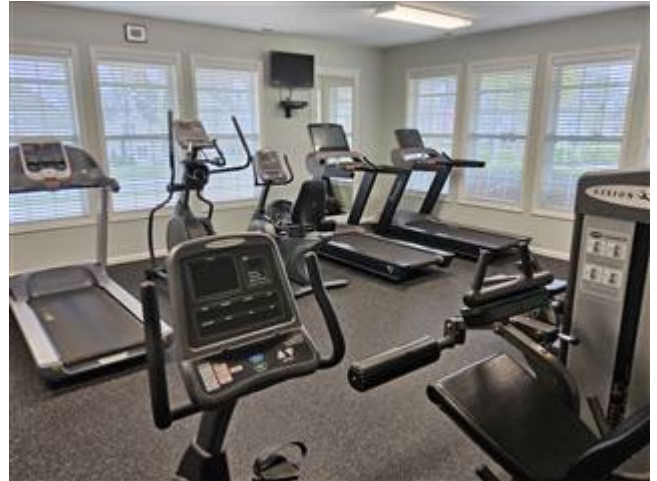
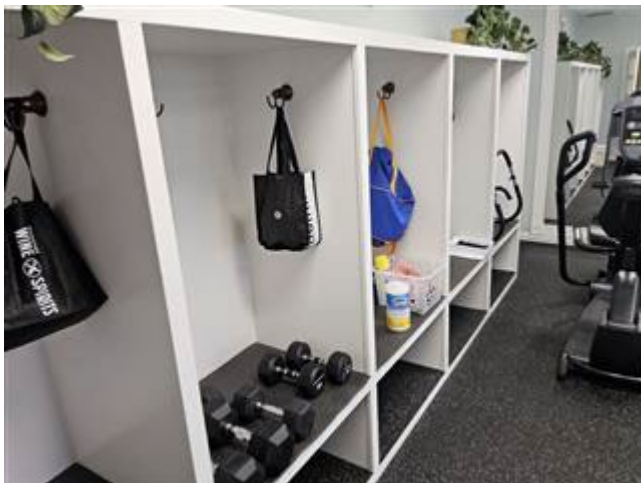
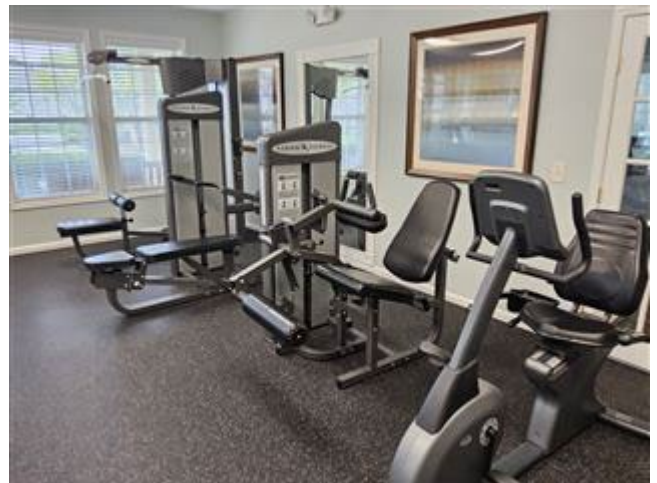
Health and Fitness Center. The Health and Fitness Center includes exercise equipment.

- Flooring. The rubber flooring appears to be in good condition. We have assumed a service life of 10 years for the rubber flooring
- Exercise Equipment. The equipment (ten pieces of varying fitness equipment) appears to be in generally good condition and fully operational. The equipment has been replaced since the last reserve assessment.
- The mirrors appear to be in good condition.
- The flat screen TVs appear to be in good condition and are operational.

- Fitness Cubby Holes for storing personal equipment are a long-life exemption as they only require occasional painting.

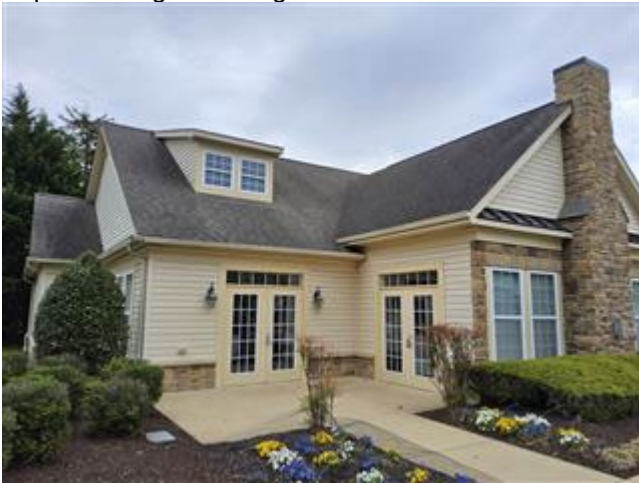
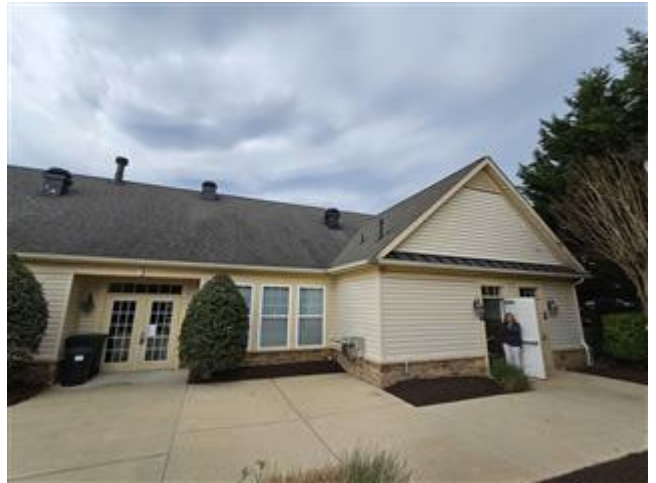
Asphalt Shingle Roofing

Building Roofing. The clubhouse's asphalt shingle roofing appears to be in fair condition, while the metal standing seam roofing appears to be in good condition. The asphalt shingles are reported to have a expected life of 30 years and have been in place for approximately 20 years.

Asphalt shingle roofs can have a useful life of 20 to 50 years, depending on the weight and quality of the shingle. Weathered, curled, and missing shingles indicate they may be nearing the end of their useful life. The standing seam metal roofing has a normal economic life of 50 to 100 years. In some cases, recoating or repainting can extend the useful life of a metal roof. Access to the roof was not provided at the time of the site visit. The roof was observed from the ground. Annual roof inspections are recommended, with cleaning, repair, and vegetation mitigation performed as needed. Contractors and personnel should perform access, inspection, and repair work with the appropriate access equipment experienced in the roofing types used for the facility.

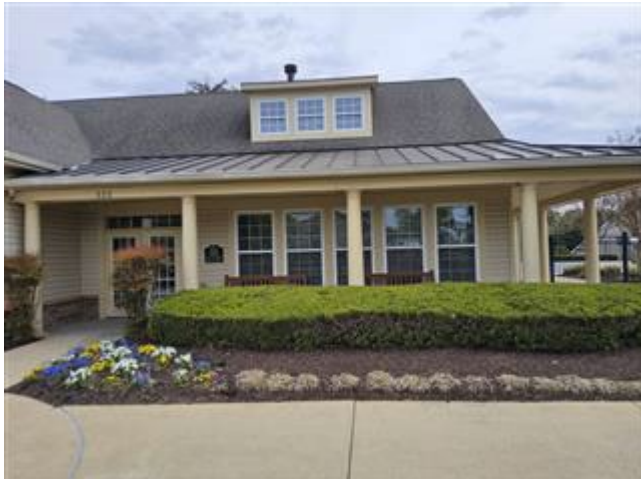
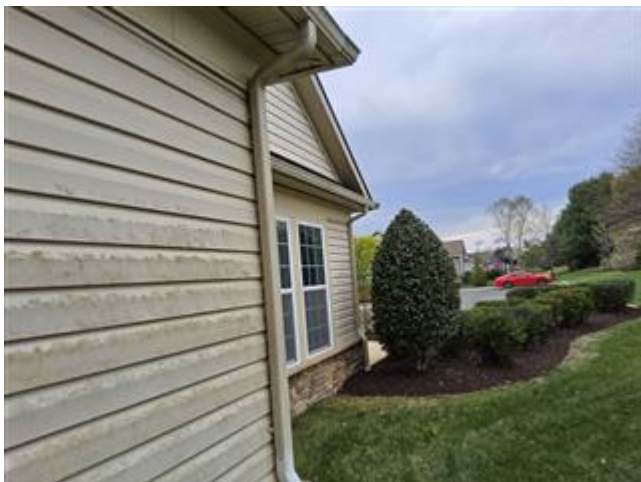
Gutters and Downspouts. The clubhouse has aluminum gutters and downspouts. The gutters and downspouts appear to be in good condition. The downspouts are attached to an underground drain system which effectively transports rain water away from the foundation.

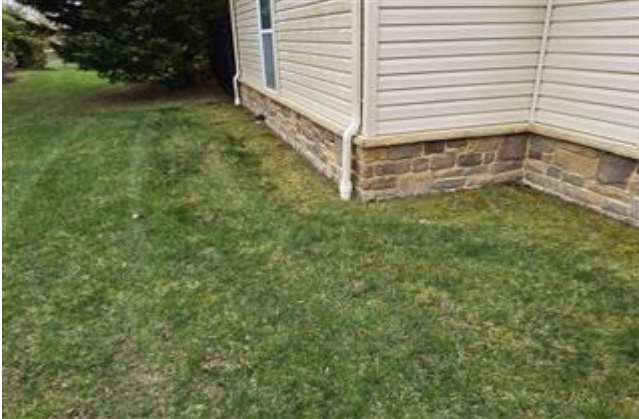
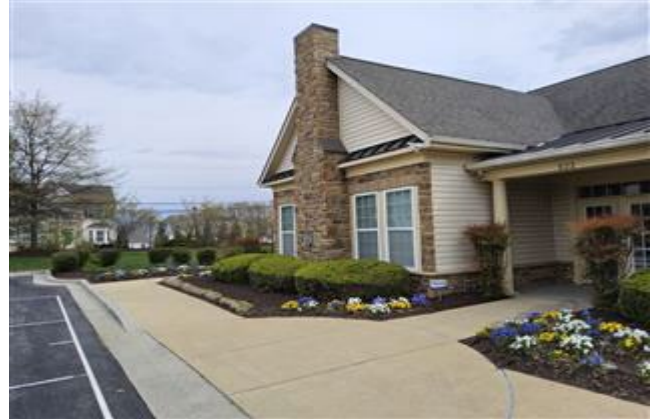
Masonry. The clubhouse has a decorative two foot masonry strip at ground level around the perimeter of the building which appears to be in good condition. The west side of the building has a masonry veneire, and the chimney is made of stone masonry. These stone masonry features are likewise in good condition.

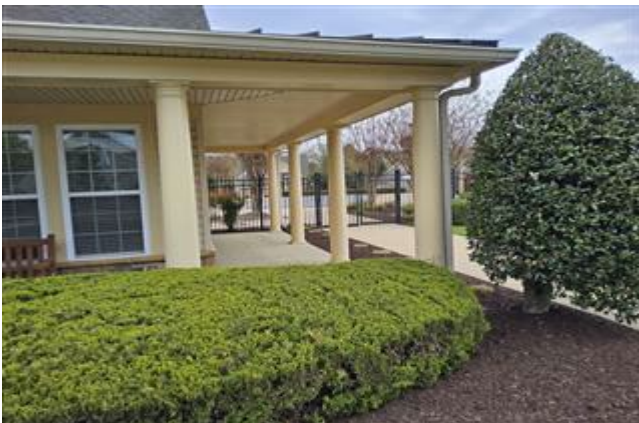
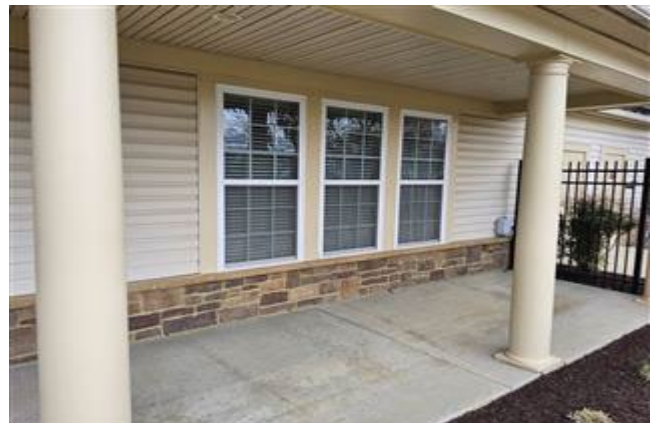
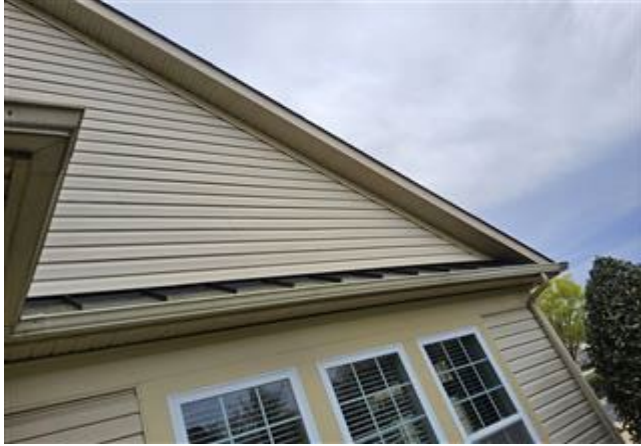
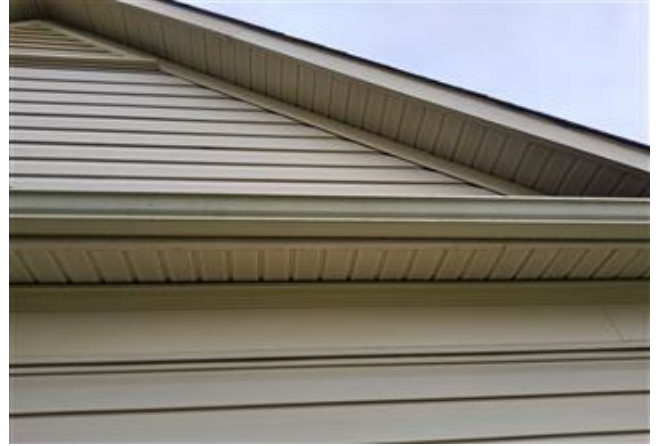
Vinyl Soffit. The underside of the roof eaves, and the front and side porches of the clubhouse are covered with vinyl soffit. This soffit is in good condition.

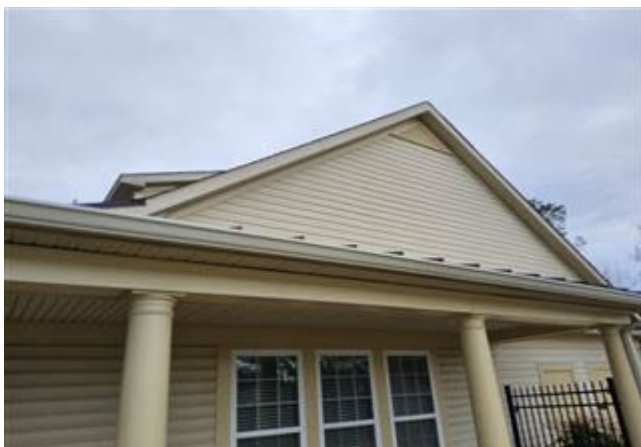
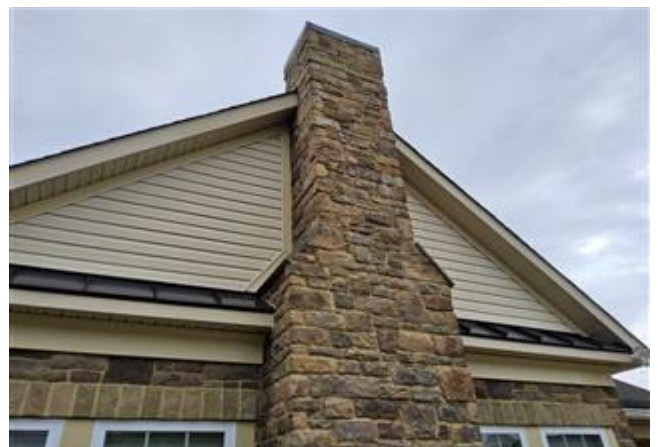
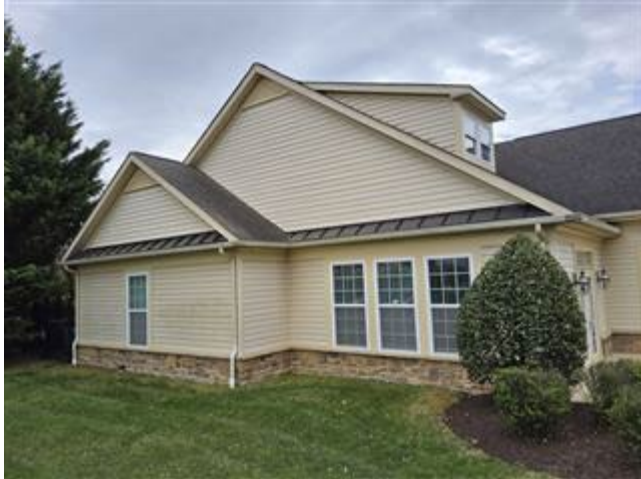
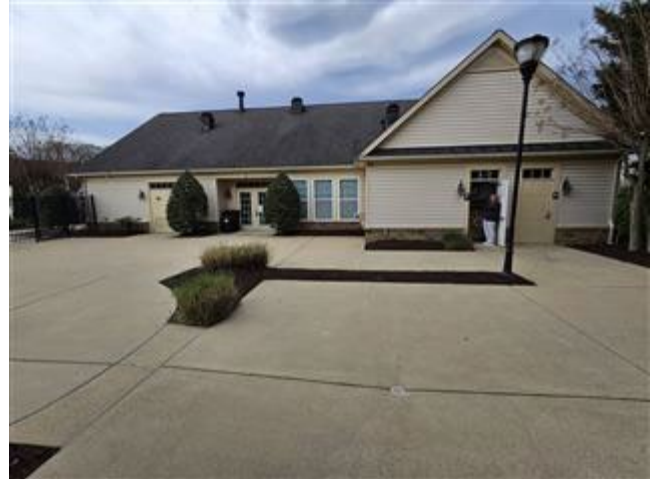
Siding and Trim. The Clubhouse is clad with vinyl siding and trim which appears to be in good condition.

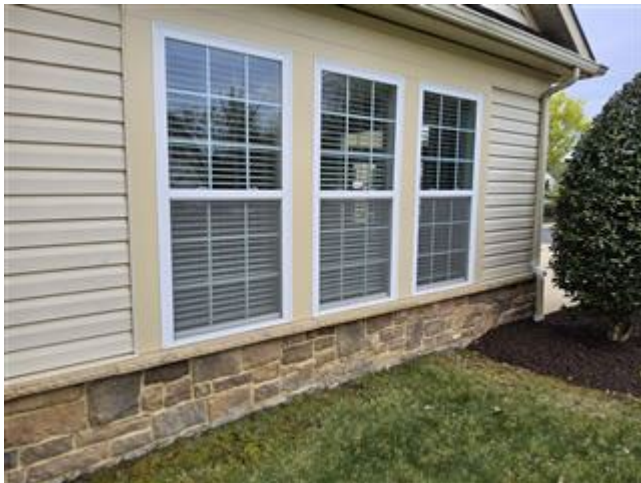
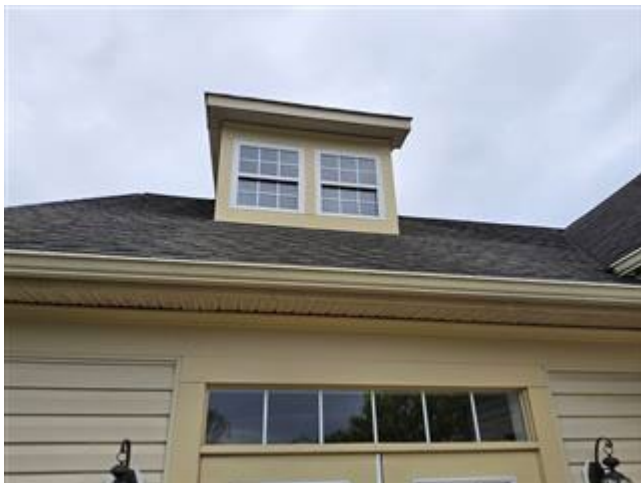
Fiberglass Windows, Double Hung. The building has 17 windows on the first floor which are 3 ft x 6 ft and 5 dormer windows which are approximately 3 ft x 3 ft. These windows are in good condition.

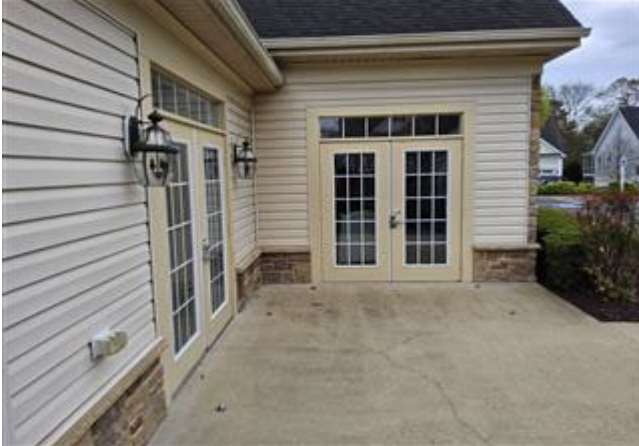
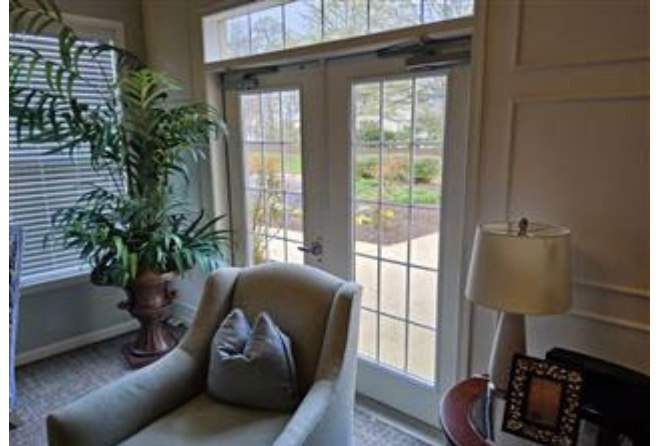
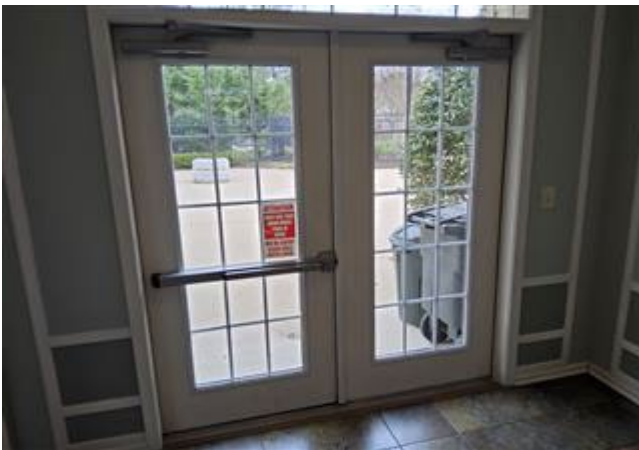
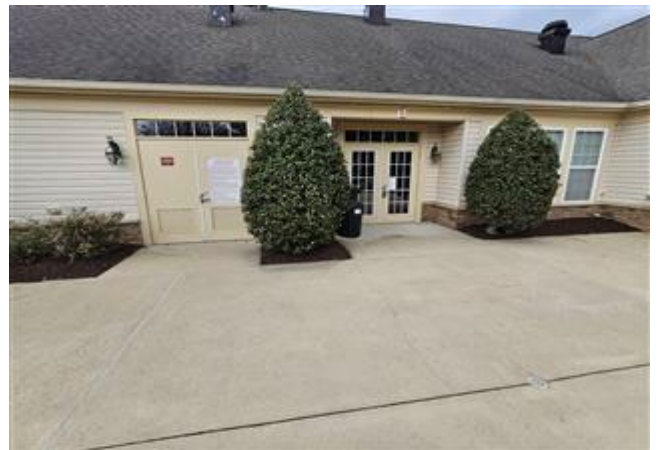
Metal and Glass Double Doors w/ Panic Hardware (Entry)

Exterior Doors. The clubhouse has several exterior metal doors. The doors are both single and double doors, with some of the doors being made of both metal and glass. Each of these doors has a one-foot glass transom over the operating door. These doors and transoms are in good condition.

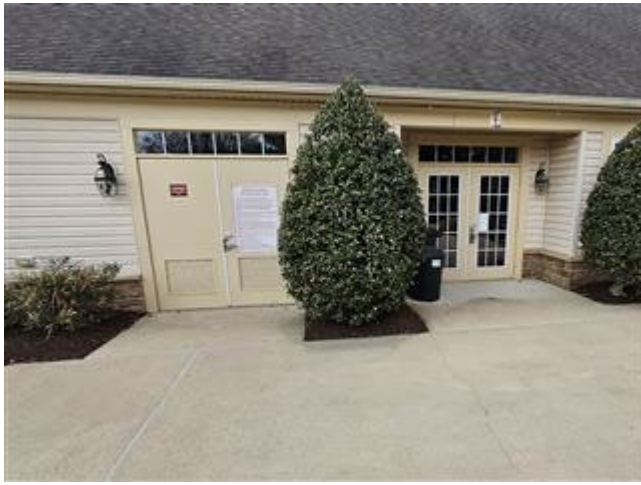
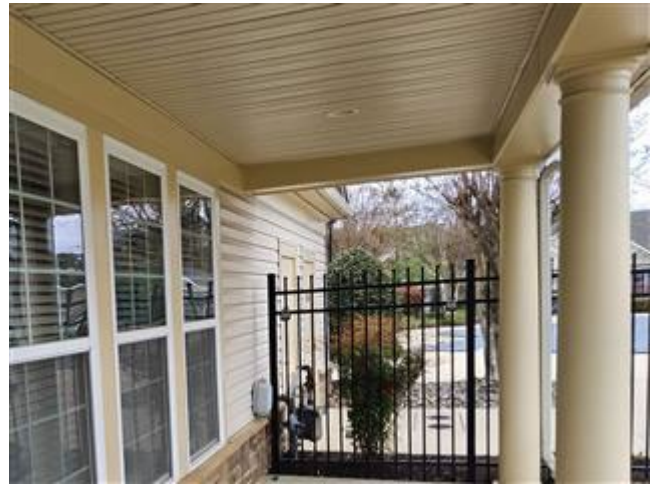
Exterior Building Lighting. The exterior lighting for the clubhouse consists of can lights under the porch and ornate carriage lamp lights. There are also two carriage lamps on the masonry piers which hold the entry gate for the North Shipley's Crossing Community. The lights are reported to be in operation, and they appear to be in good condition.

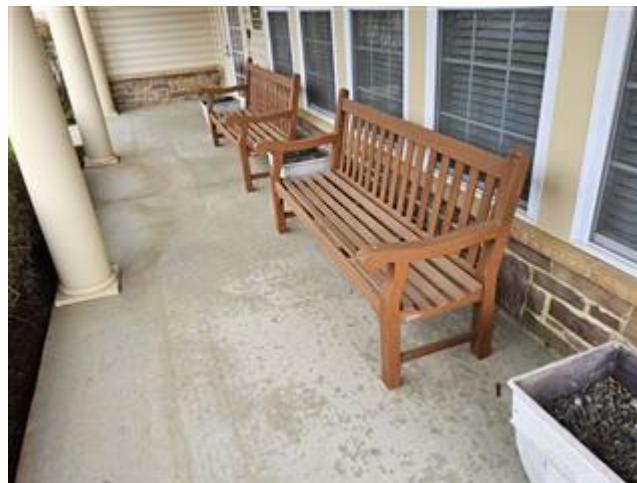
Outdoor Wooden Benches. There are two exterior wooden benches under the front porch, these benches are in good condition and covered from direct sunlight.

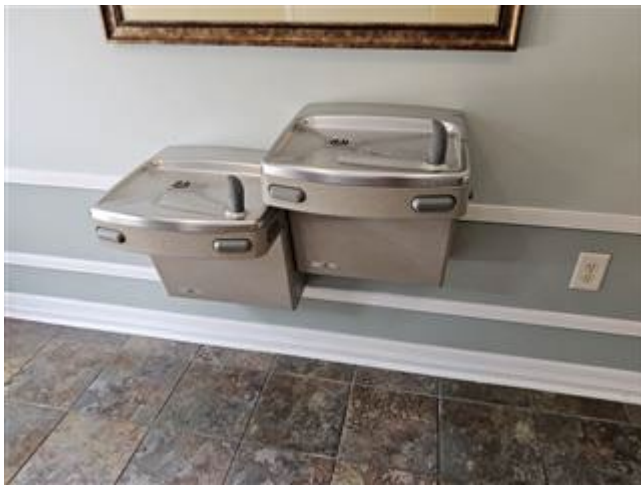
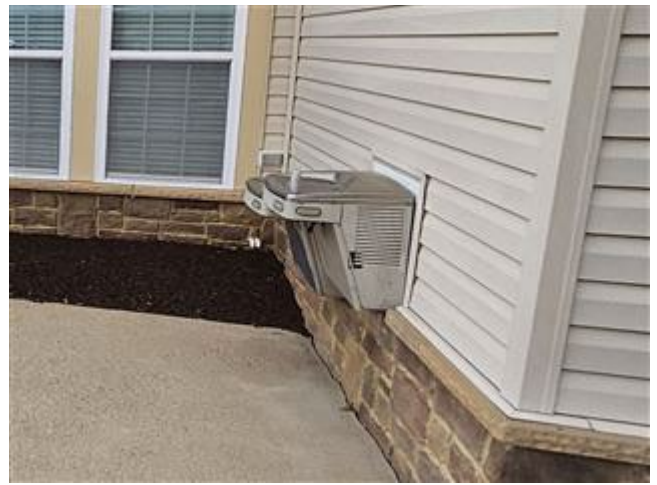
Dual Station Drinking Fountain, Refrigerated. The Clubhouse has two refrigerated dual station drinking fountains. They are located in the lobby of the clubhouse and another on the exterior wall of the clubhouse near the swimming pool, inside the fenced area. These drinking fountains appear to be in good condition.

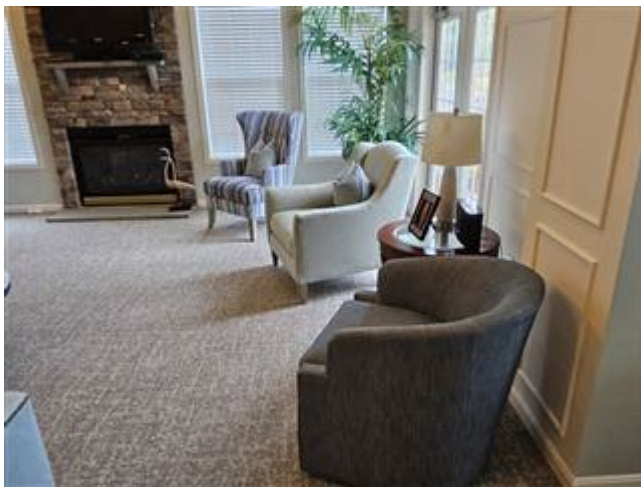
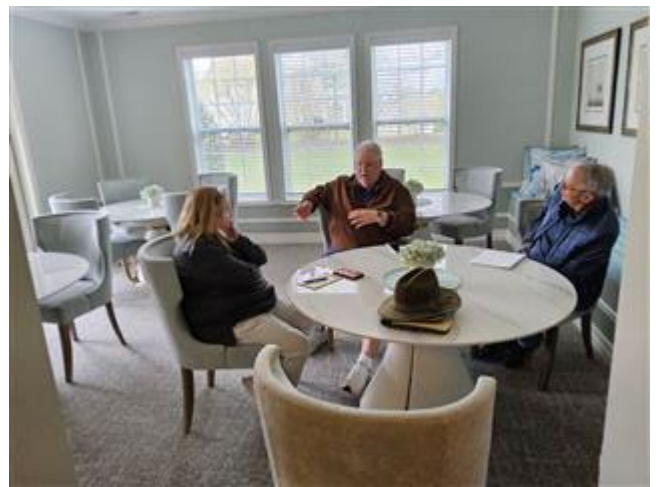
Carpet Tile. The carpet in the building's main and card rooms appears in good condition. The commercial carpet tile of this construction in this type of application has a typical service life of 7 to 10 years.

To extend carpet life, the Association must continue with a comprehensive maintenance program that includes regular vacuuming, spot and spill removal, interim cleaning of high-traffic areas, and regularly scheduled cleanings. It is also recommended that all entrances be fitted with walk-off mats to trap soil.

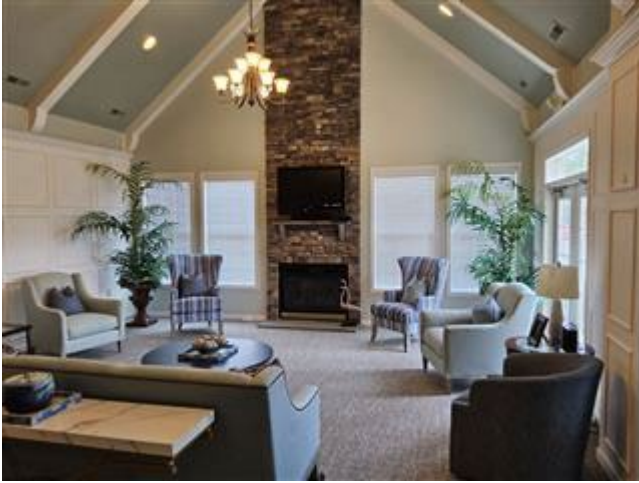
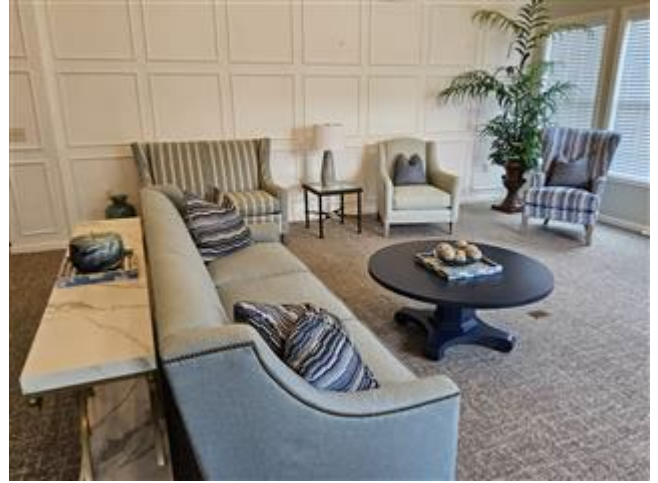
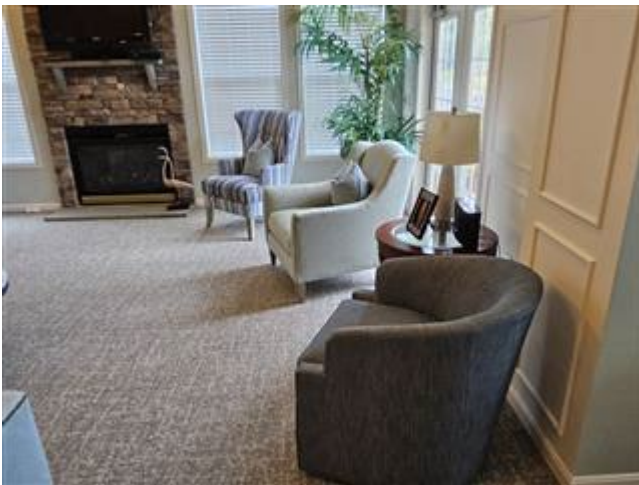
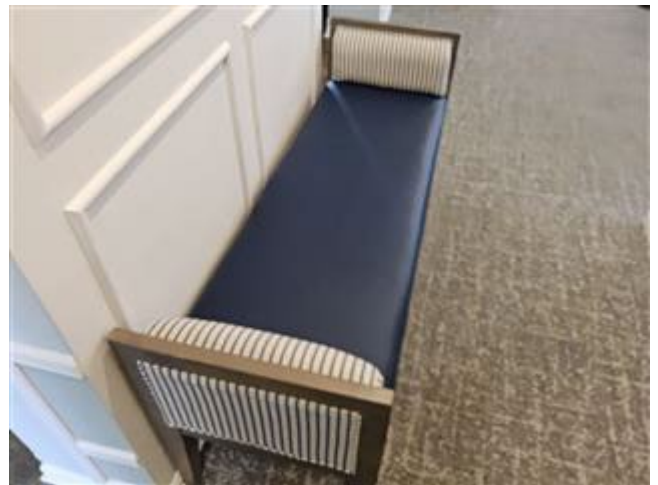
Main Room.

Card Room and Main Room Furniture. The main entertainment rooms are tastefully outfitted with comfortable furniture and a flat screen television with cable, which complements the atmosphere of these two rooms. The furniture is a mixture of tables, sofa, love seats, lamps and chairs. This furniture and TV appear to be in good condition.
