LEVEL 2 REPLACEMENT RESERVE REPORT FY 2026 SHIPLEYS CROSSING HOA

SHIPLEYS CROSSING HOA

MILLERSVILLE, MARYLAND

April 23, 2025

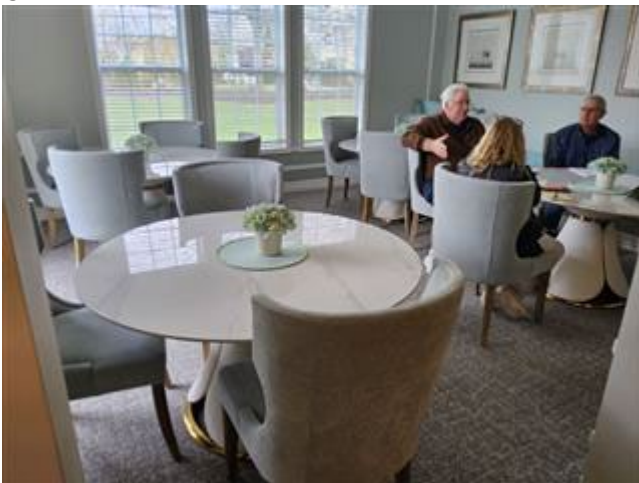
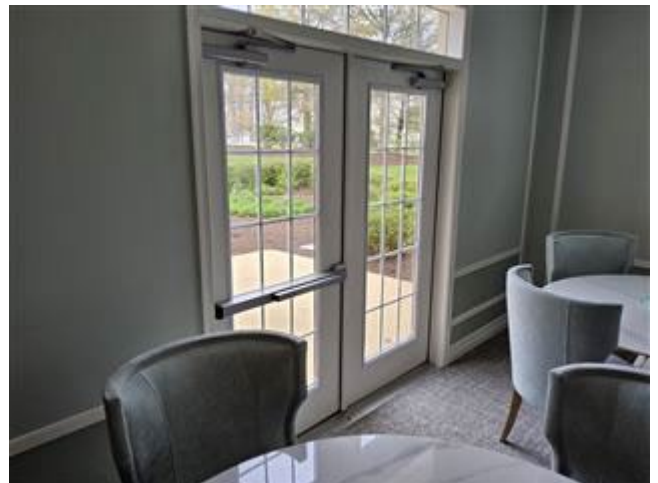
Card Room.

Card Room and Main Room Furniture. The main entertainment rooms are tastefully outfitted with comfortable furniture and a flat screen television with cable, which complements the atmosphere of these two rooms. The furniture is a mixture of tables, sofa, love seats, lamps and chairs. This furniture and TV appear to be in good condition.

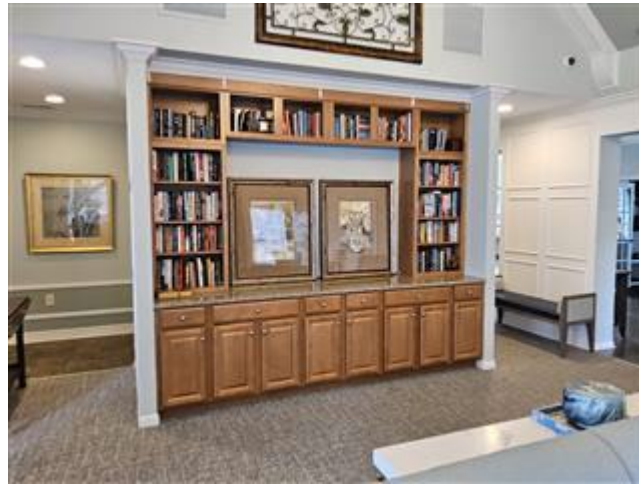
Custom Built Book Case/Cabinet. The Association has a custom-built book case and storage cabinet in the main room of the clubhouse. This piece of furniture is built specifically for the location, appears to be made of hard wood, has a granite counter top, is of high-quality, and is in good condition.

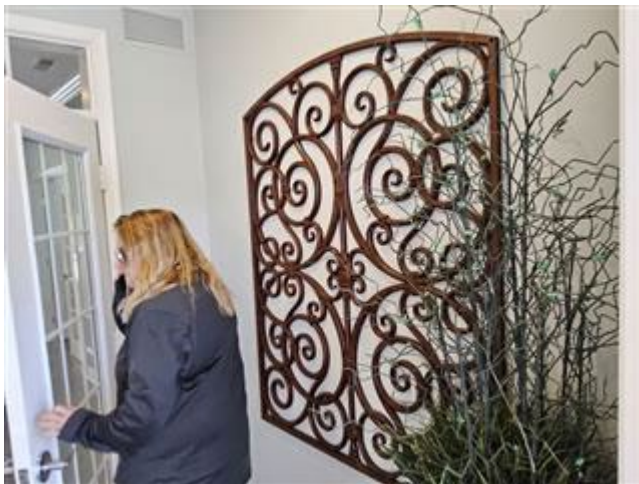
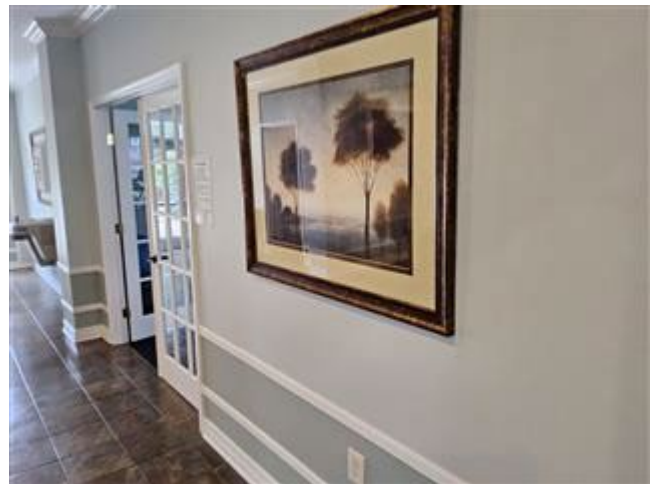
Art Pieces and Mirrors. The clubhouse has numerous pieces of art and mirrors spaced throughout the building. These pieces are in good condition and add much to the atmosphere of the facility.

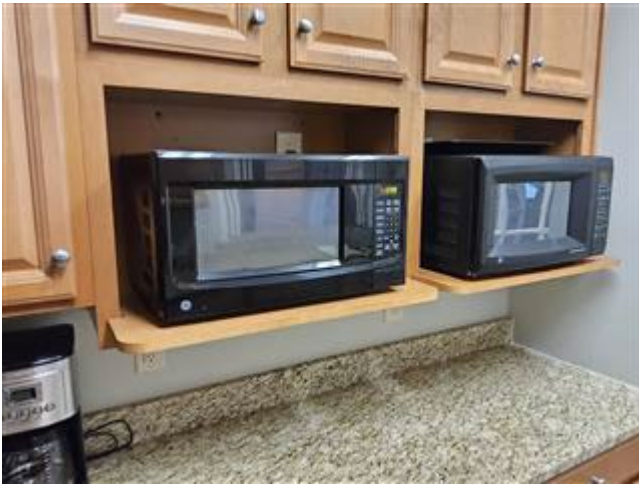
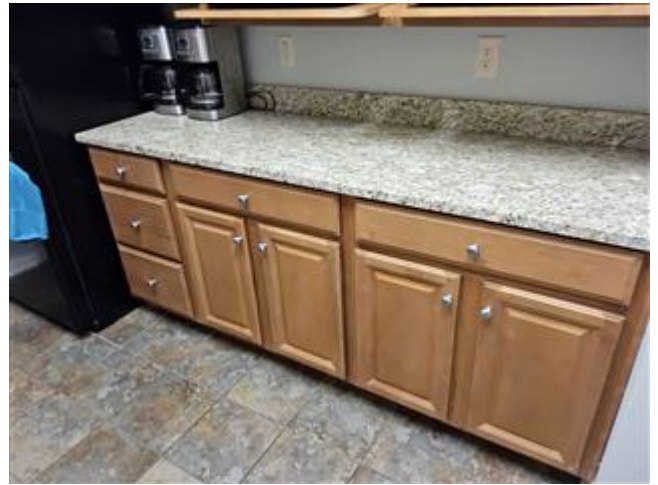
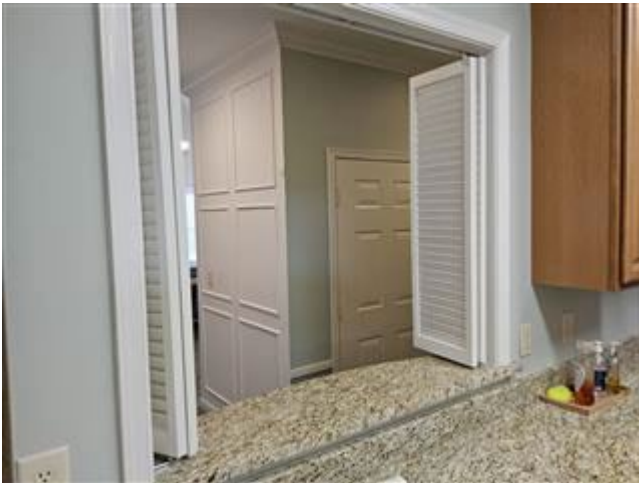
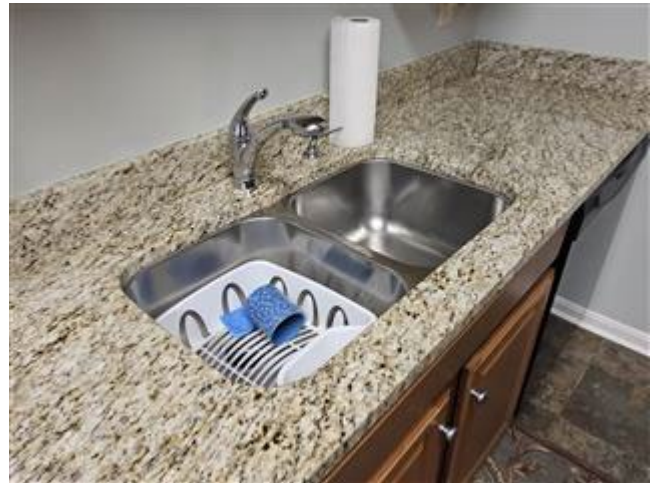
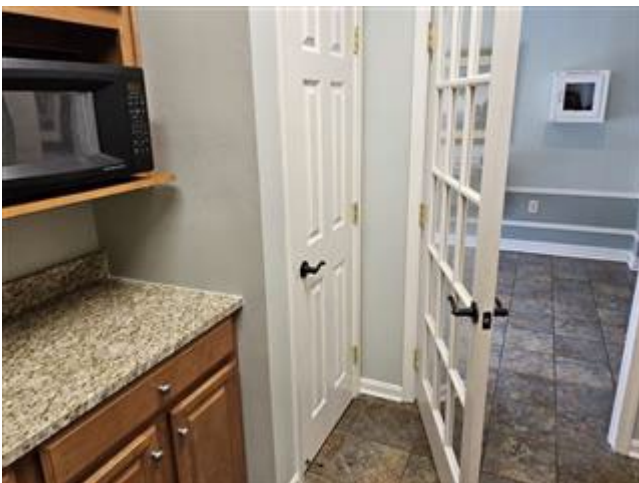
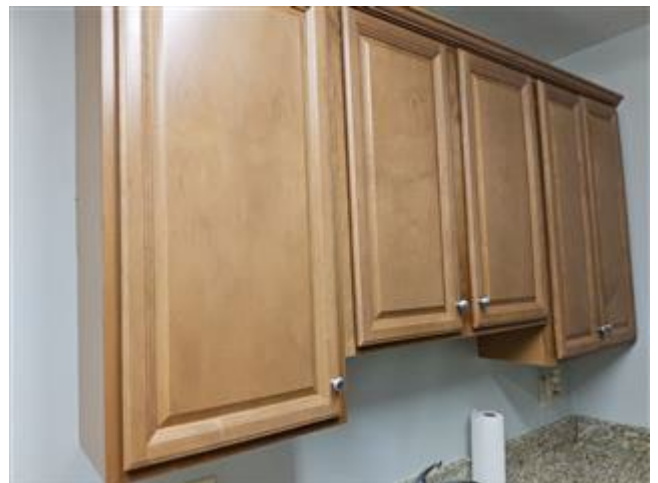
Kitchen Outfitting. The kitchen is outfitted with what is needed for entertaining in the main room and card room. It has coffee makers, microwaves, dishwasher, sink granite counter tops, refrigerator, and ample storage space. The equipment and built-in cabinets counters and equipment are in good condition and well taken care of.

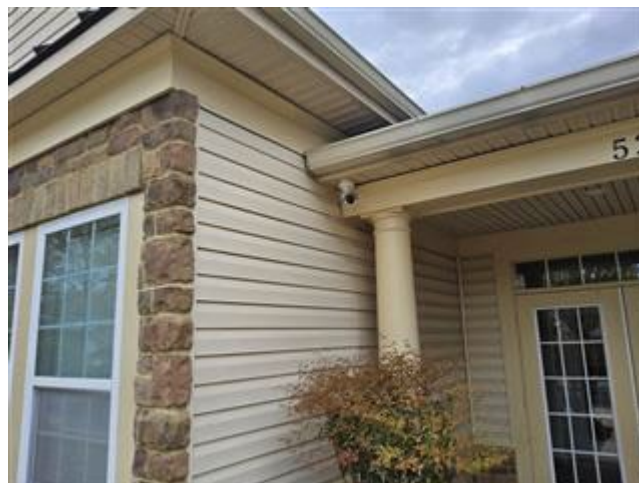
Building Security System and Entry System. The clubhouse has a security entry system with alarms and cameras. The security access and camera system is located in the storage room. The system is reported to be operational and in good condition. The system was not tested as this is not within the scope of the reserve study, and should be accomplished by security system professionals.

Systems of this type typically have a service life of 15 to 20 years. Beyond that point, it becomes increasingly difficult to find replacement parts. Additionally, changes in technology help render the systems obsolete. For these reasons, we have assumed a 15-year service life for this type of system.

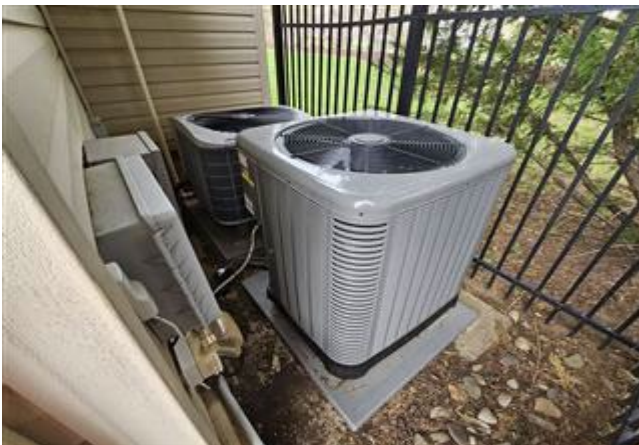
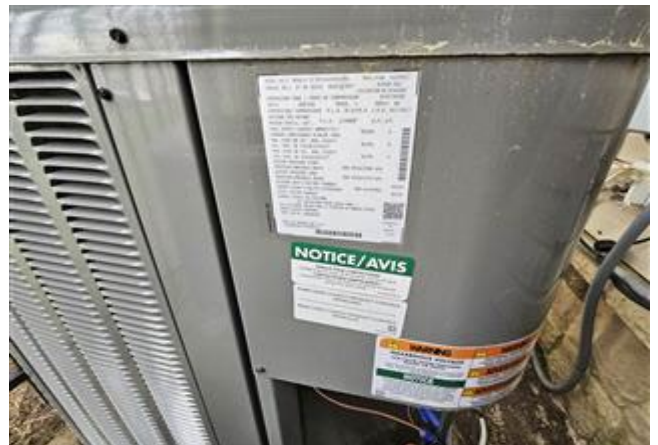
Split HVAC Systems. The clubhouse features two split-system HVAC units. The systems include a furnace, coils, and a remotely located compressor. The smaller compressor was manufactured by Carrier in February 2008, and the larger unit was manufactured by Rheem in October 2023. The furnaces are located in the attic of the clubhouse but were not available for assessment during the site visit. The systems are reported to be in good working order.

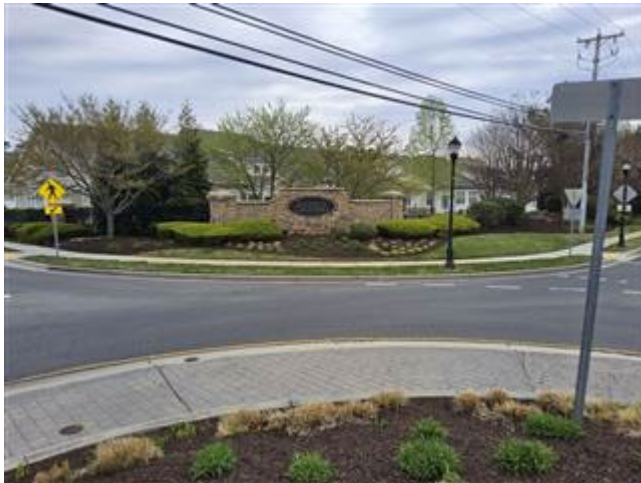
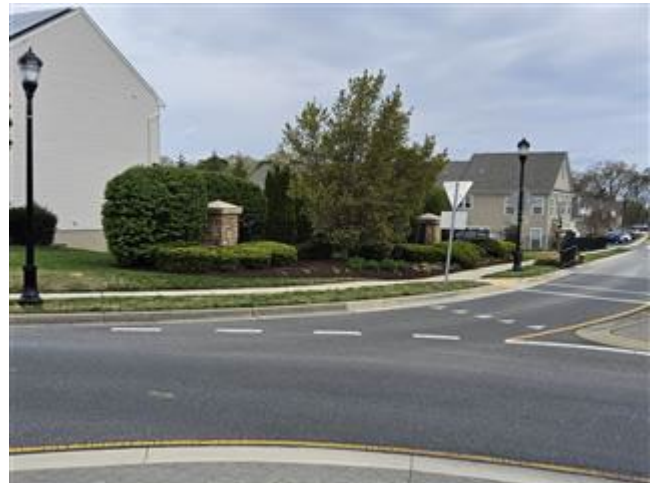
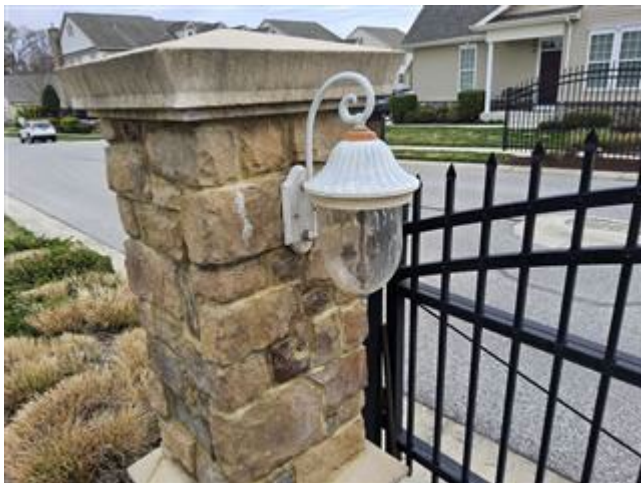
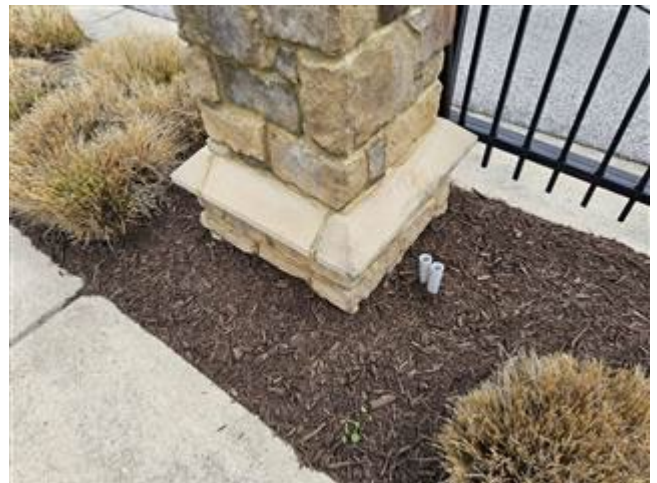
Entry Monument and Signage. The Association maintains one entry monument, two smaller piers which hold a gate, and monument piers placed on the north two corners of the intersection of Brightview Drive, Galliot Drive, and Tremont Drive. The monuments and piers are made of rock of varying degrees of hardness, including soft sedimentary stone. The masonry joints were found to be open in some areas indicating water penetration into the masonry work. The three monument signs are made of painted composite material. The monuments, signage and piers are all in good condition, and have been in place since the construction of the community approximately 15 years ago.

We recommend re-pointing and replacement of defective areas of the masonry in the few areas needed where cracking is visible. Pointing these areas soon will minimize water intrusion and further cracking. The Association may want to consider applying a coating of Siloxane or other appropriate breathable sealants to mitigate water penetration and further degradation of the masonry work. This study does not consider traffic and street signs as they are considered value exclusions and should be replaced using other funds.

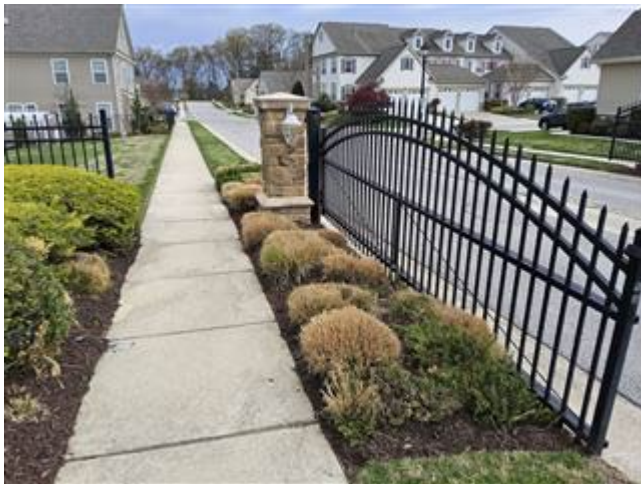
Vehicle Swing Gate. The north community access point has a black powder coated metal swing gate that does not currently have a vehicle access system or power installed. The conduit for the access system appears to be in place, but the gate also appears to be only manually operated. We understand that there are no plans to operate the community as a gated community. In the future if the community wishes to be a gated-community it will need to fund this modification with other than reserve funding.. The gate is attached to two smaller masonry piers with carriage lights. The gate appears to be operational and is in good condition.

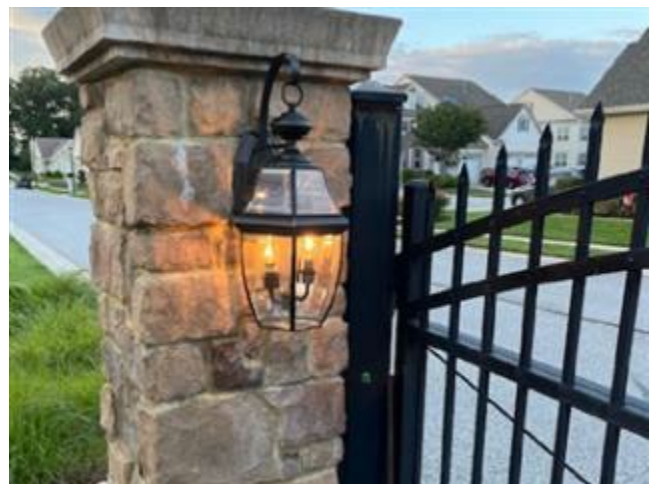
Site Lighting. The Association is responsible for the operation of the facility's two landscape flood lights that highlight the north entry monument, and the carriage lights on the small piers that support the manual swing gate. The north two lights appear to be in good condition. The carriage lights are operational.

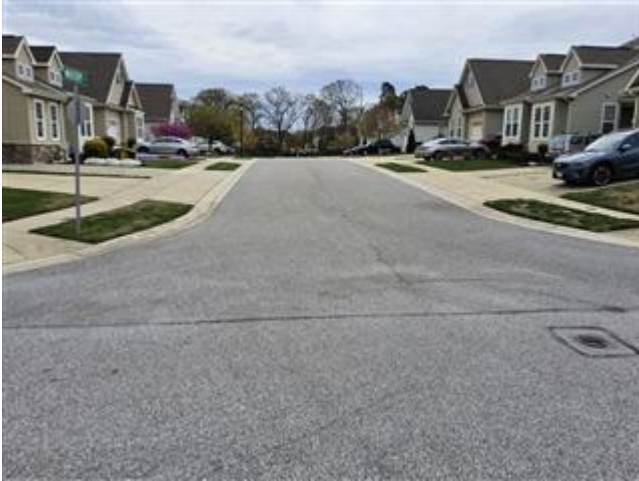
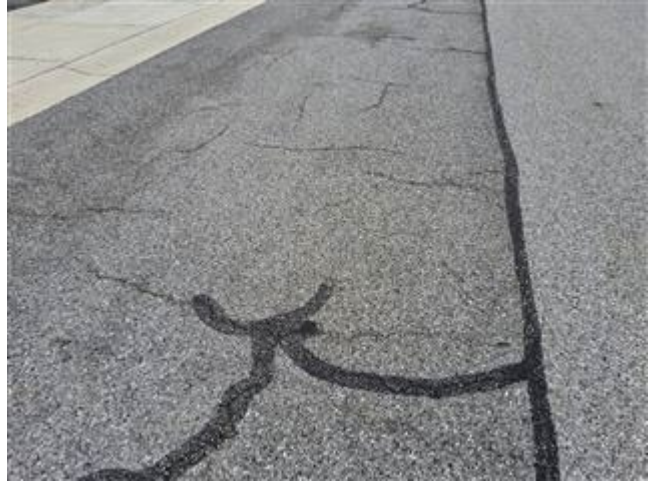
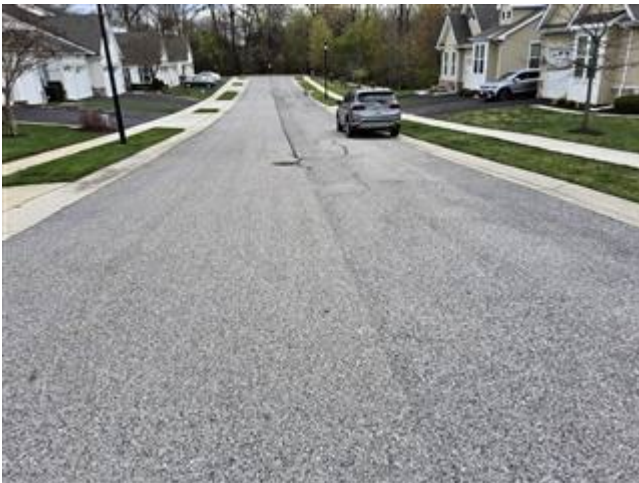
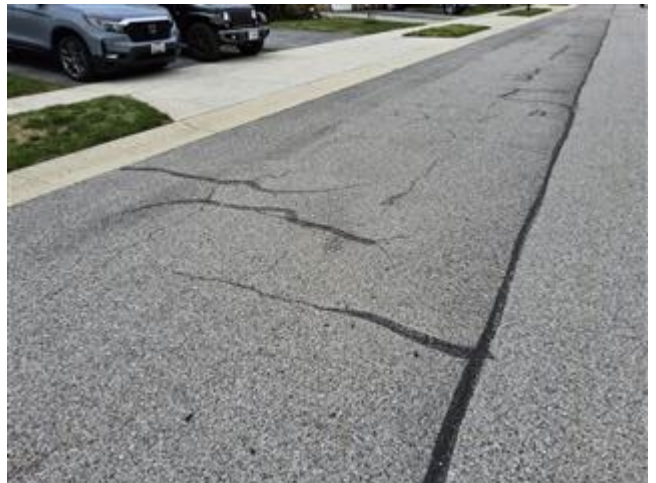
North Shipley's Crossing Asphalt Roads.

Asphalt Pavement. The Association is responsible for the roadways and parking areas within the north section of the community. In general, the Association's asphalt pavements appear to be in good condition.

The pricing is based on recent contracts for a two-inch overlay, which reflects the current local market for this work.

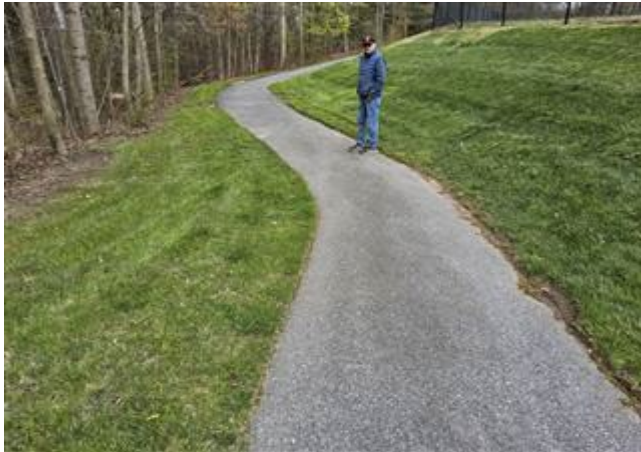
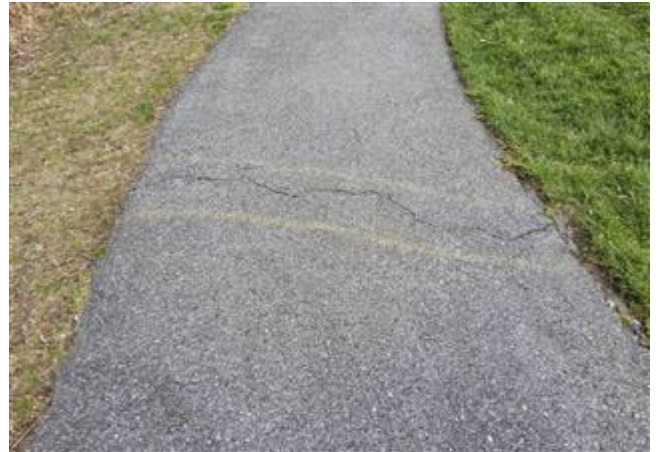
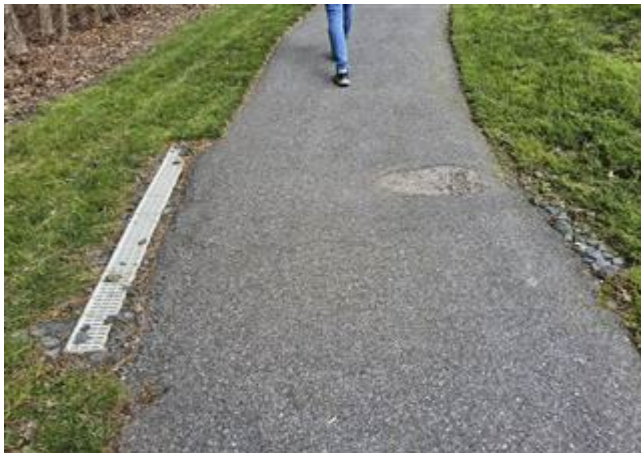
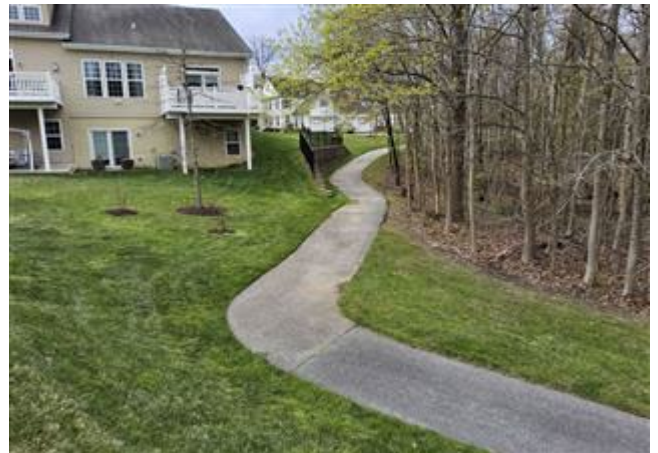
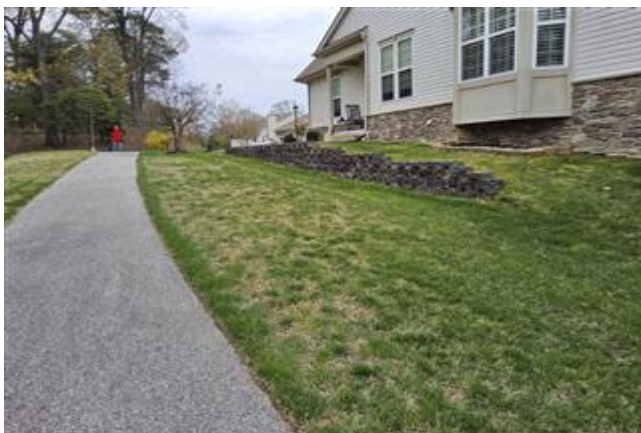
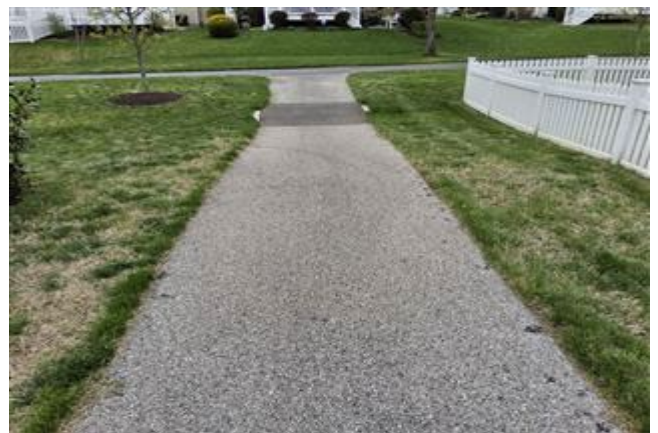
Asphalt Paths. The Association is responsible for the paths throughout the north side of the community. The paths appear to be in good condition with minimal cracking, trip hazards and damage from tree roots. The Association has installed lateral drains in areas where water collects which keep water from pooling and damaging the sub-base of the paths.

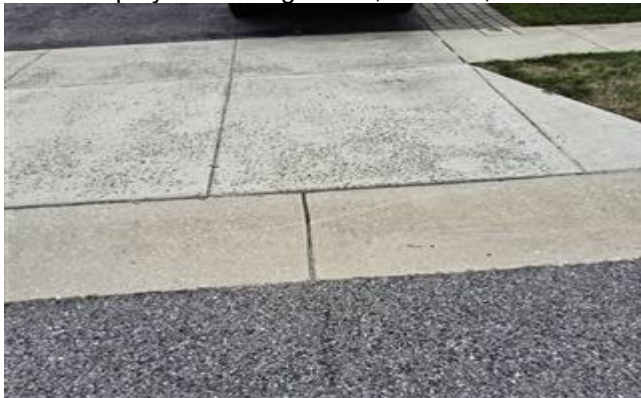
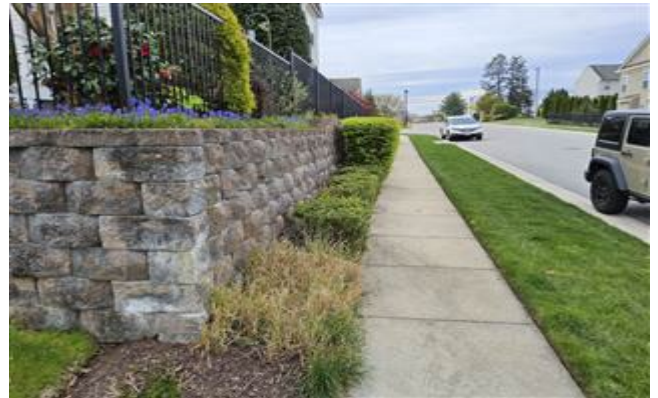
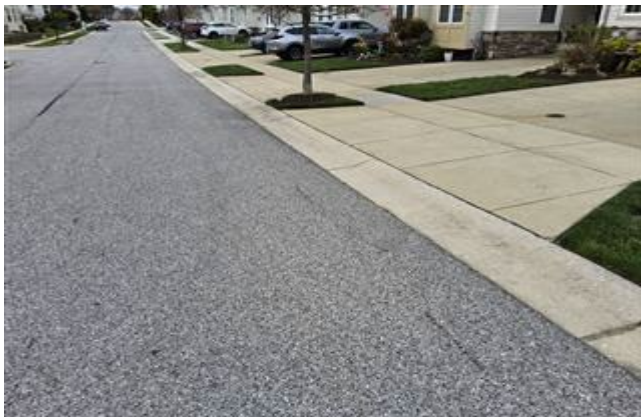
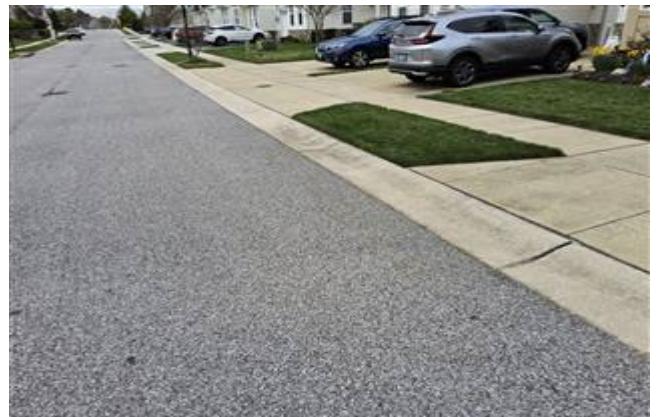
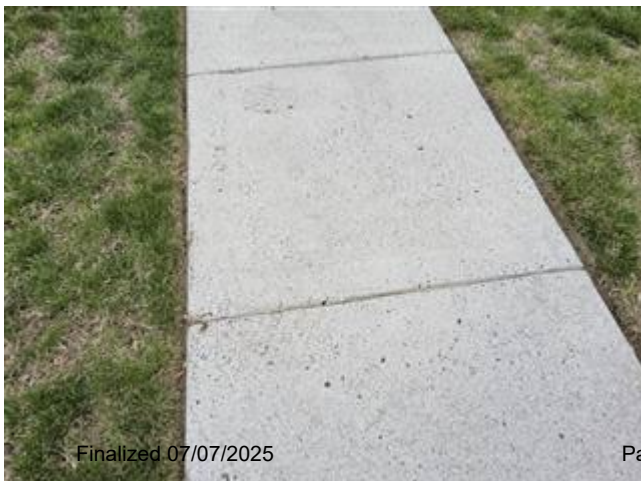
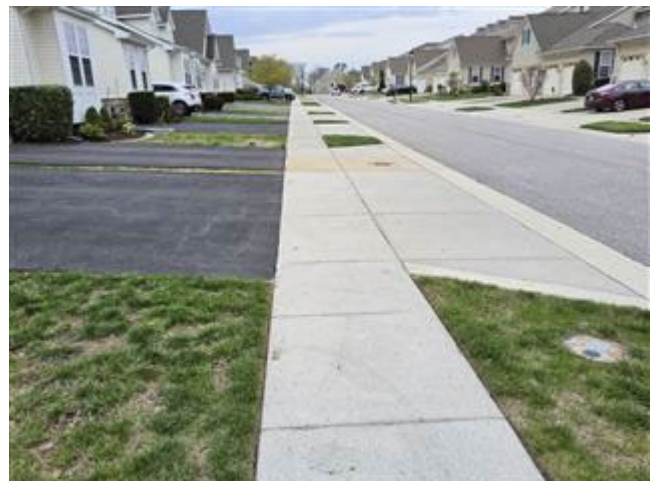
North Shipley's Crossing Curbs, Gutters, Sidewalks and Aprons

Concrete Work. The North Shipley's Crossing community's concrete work includes aprons, sidewalks, curbs, and gutters as well as other flat work. We have modeled for curb replacement when the asphalt pavement is overlaid. The overall condition of the concrete work appears to be in good condition with some popouts and cracks starting to be observable.

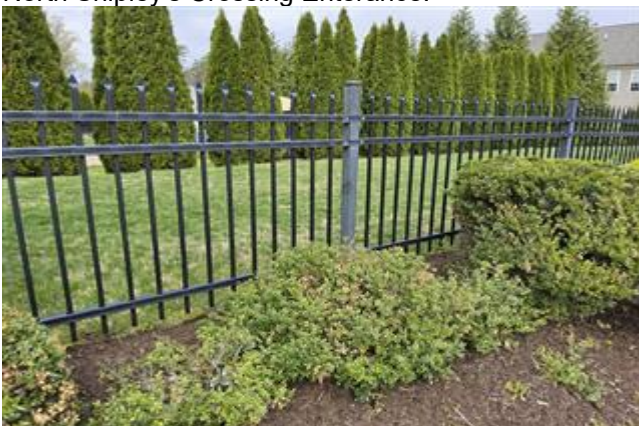
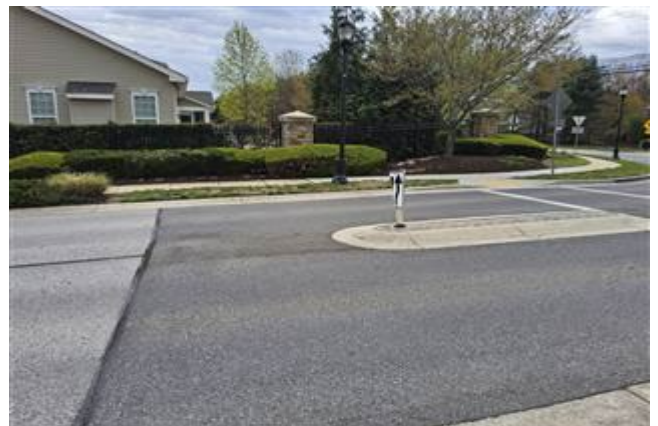
North Shipley's Crossing Entrance.

Decorative Aluminum Fencing. The Association maintains decorative aluminum fencing at the entrance to the community and on top of retaining walls that appear to be in good condition. Fencing systems have a large number of configurations and finishes that can usually be repaired as a maintenance activity by replacing individual components as they become damaged or weathered.

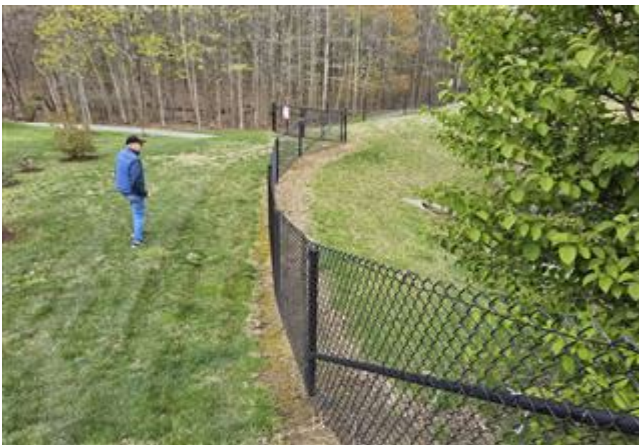
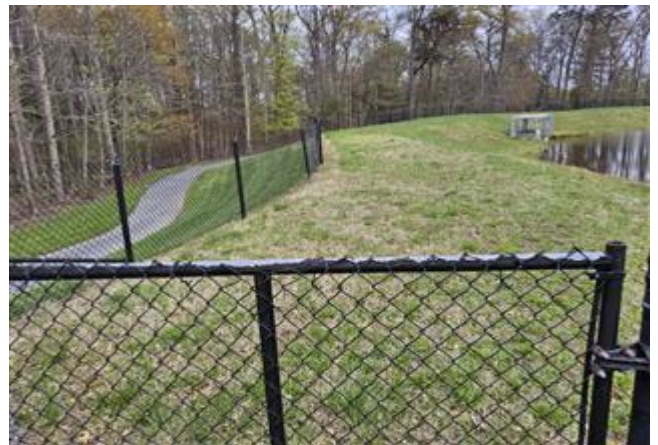
Vinyl Coated Chain Link Fencing. The Association maintains chain link fencing as a perimeter around the two retention ponds with four chain link gates that appear to be in good condition. Fencing systems have a large number of configurations and finishes that can usually be repaired as a maintenance activity by replacing individual components as they become damaged or weathered.

The Association maintains steel fence posts and fasteners that are embedded in concrete or masonry. As part of normal maintenance, we recommend the following:

- Lift or remove ornamental base covers, if applicable.
- Remove the existing caulk completely.
- Clean, prime, and paint all posts.
- Apply an appropriate caulk around each post base.
- Tool and shape caulking to shed water from the post.

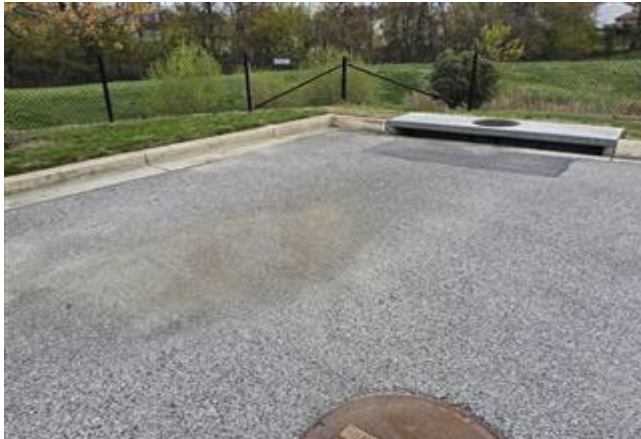
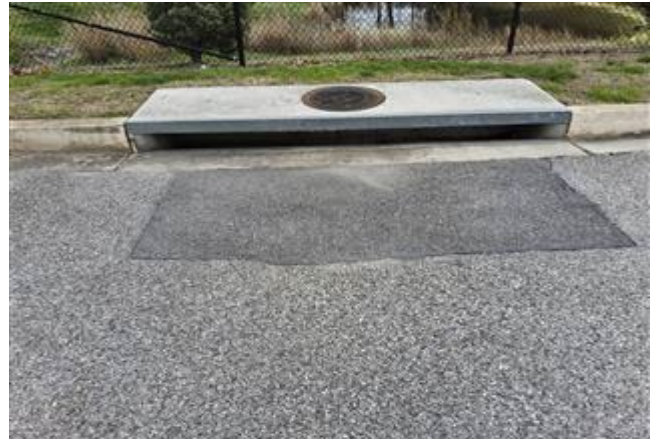
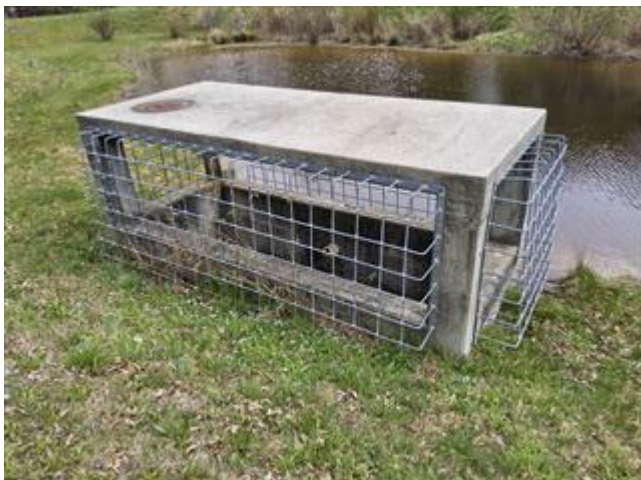
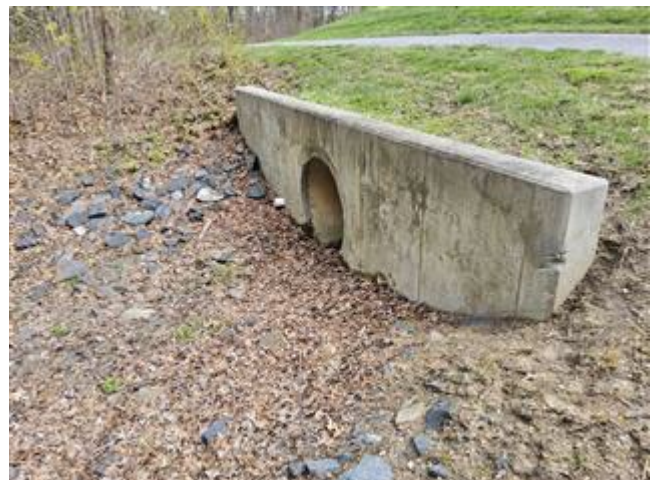
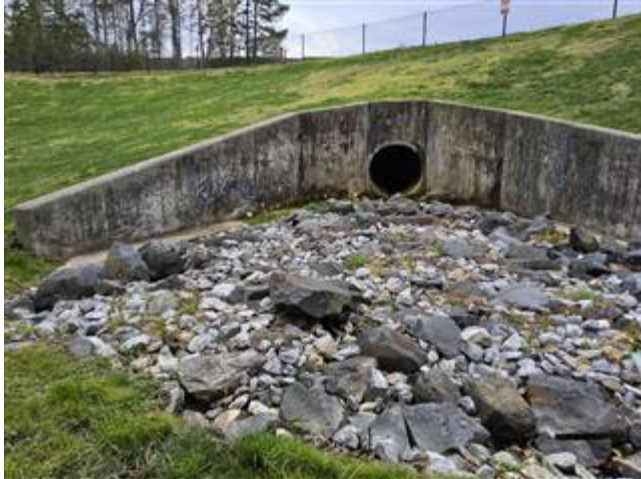
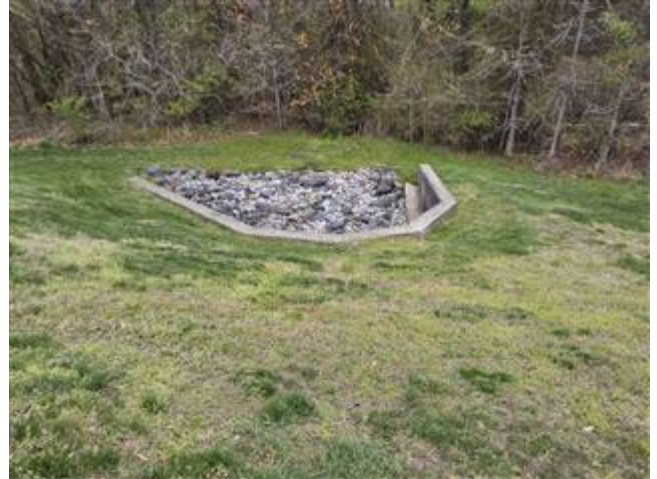
Stormwater Management. The community features stormwater management. The stormwater system consists of surface drainage, structured drainage, erosion control, and runoff. The overall condition of the stormwater management is good. The concrete over spill structures as well as headwalls and outflows are long life items which require little or no maintenance and repair funding. Storm water reserve funding which is programmed is for the patching off concrete fixtures if needed, as well as the replacement of rip rap in the two outflow areas to minimize erosion damage from fast running water during storms. The community should maintain the stormwater system to function as designed, limit erosion, and channel water to the drainage system.

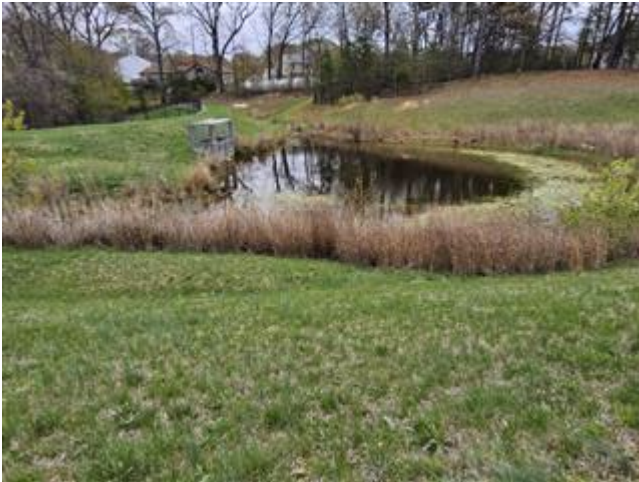
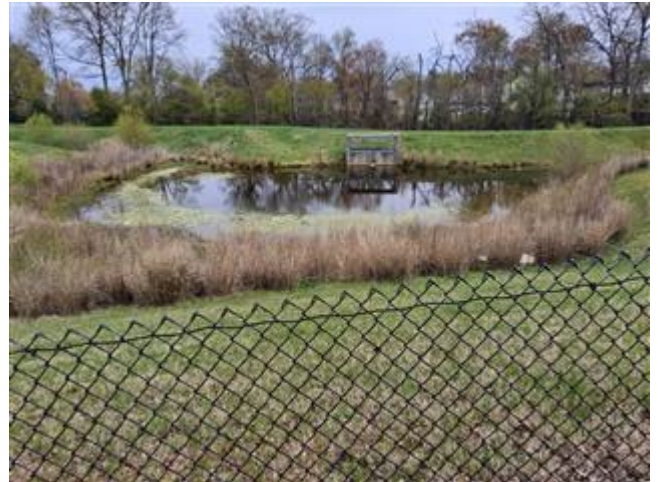
East Retention Pond.

Retention (Wet) Ponds. The two wet retention ponds that the HOA is responsible for are designed and constructed stormwater retention pools where physical, biological, and chemical processes can remove pollutants from stormwater runoff. Pollutants removed include suspended solids, organic matter, dissolved metals, and nutrients. Retention ponds control stormwater flow, which prevents downstream flooding. As stormwater enters the pond, treated water is displaced and discharged into a receiving body of water. Enhanced treatment of stormwater runoff can be achieved through extended detention and the use of aquatic plants on the pond's perimeter. Pond depth can play a critical role in pollutant removal and storage, but caution should be taken when increasing the depth of the pond. Water within the pond is discharged through a wet pond outlet. The wet pond outlets consist of a concrete vertical riser, attached to a horizontal barrel that conveys stormwater flow under the embankment to a receiving stream. The outlet is designed to pass excess water while maintaining a permanent pool. Risers are typically placed in or on the embankment's edge and capped with a trash rack to prevent clogging. This is precisely how the two Shipley's Crossing Ponds are designed and constructed.

- Survey the ponds to establish the current profile of the bottom. After five years of operation, re-survey the pond to establish new depths to determine the local siltation rate. This will establish the frequency required for periodic dredging.
- Periodically sample and test for contaminants.
- Consult with local contractors to determine the cost of removing and disposing of the spoil once its nature is known. Firms specializing in this work can typically be found by searching Lake and Pond, Construction and Maintenance for your state or area of the country. Some states provide shortlists of companies that specialize in this type of work.

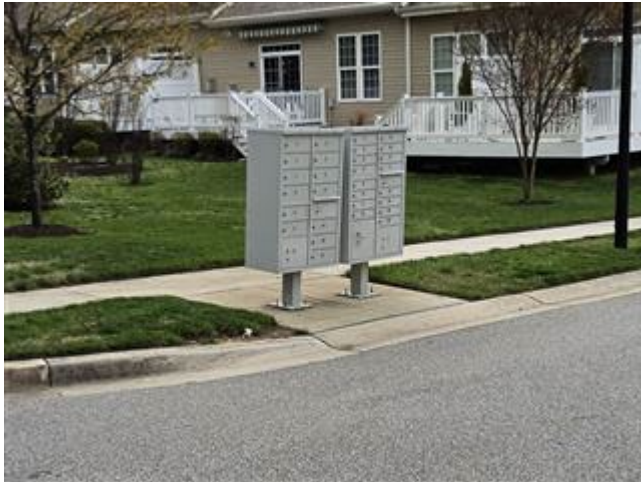
Mailboxes. The North Shipley's Crossing Community has five cluster mailboxes located throughout the community. These mailboxes appear to be in good condition.

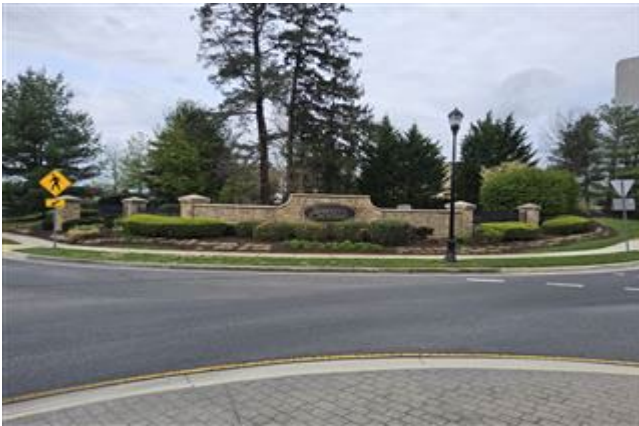
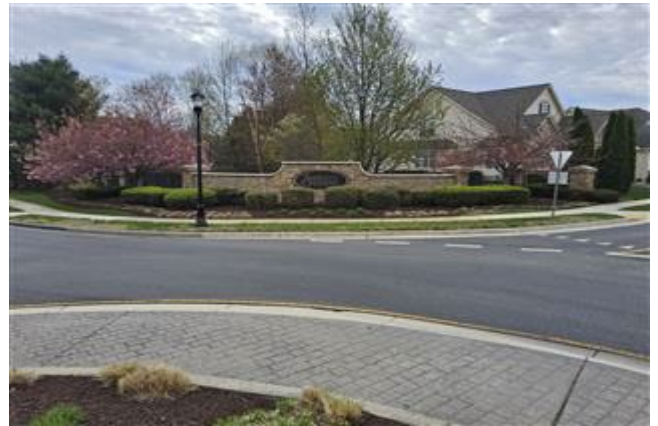
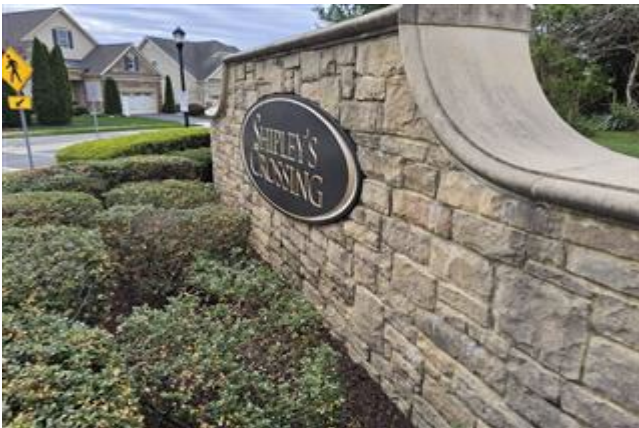
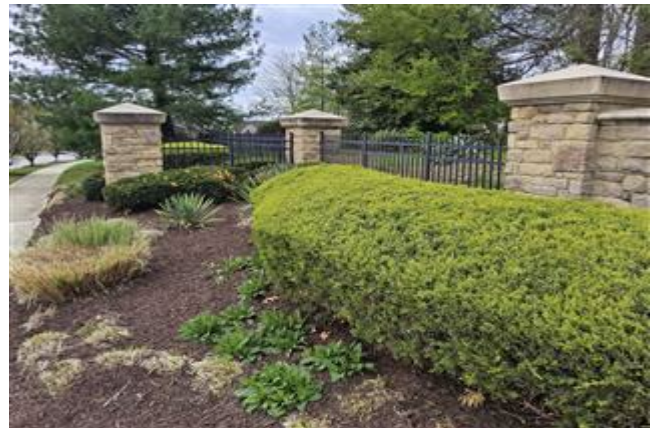
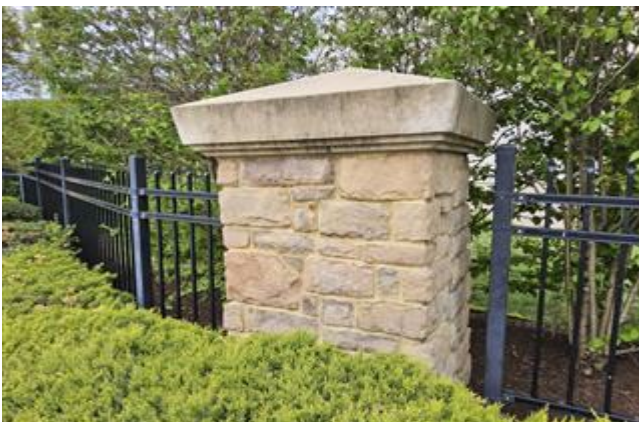
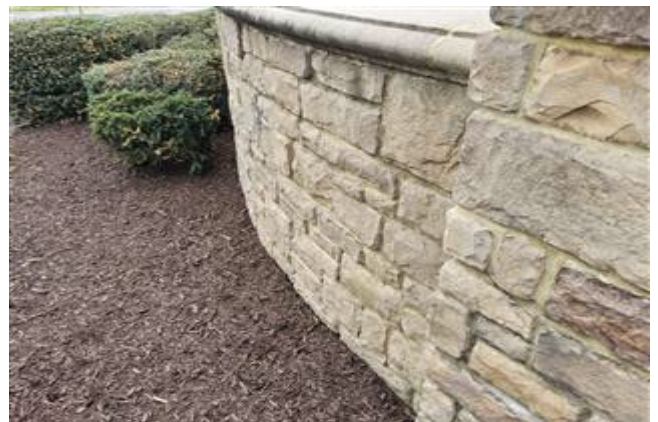
Entry Monument and Signage. The Association maintains two South Shipley's Crossing monuments, monument piers placed on the two southern corners of the intersection of Brightview Drive, Galliot Drive, and Tremont Drive. The monuments and piers are made of rock of varying degrees of hardness, including soft sedimentary stone. The masonry joints were found to be open in some areas indicating water penetration into the masonry work. The two southern monument signs are made of painted composite material. The monuments, signage and piers are all in good condition, and have been in place since the construction of the community approximately 15 years ago.

We recommend re-pointing and replacement of defective areas of the masonry in the few areas needed where cracking is visible. Pointing these areas soon will minimize water intrusion and further cracking. The Association may want to consider applying a coating of Siloxane or other appropriate breathable sealants to mitigate water penetration and further degradation of the masonry work. This study does not consider traffic and street signs, as they are considered value exclusions, and should be replaced using other funds.

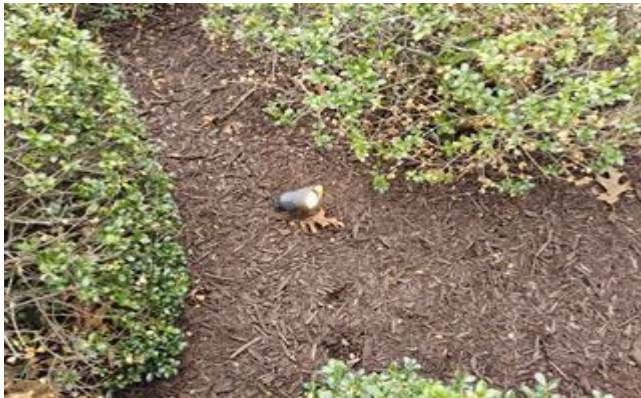
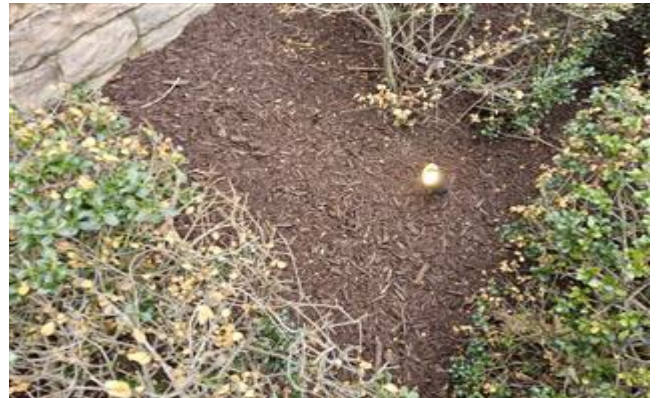
Site Lighting. The Association is responsible for the operation of the facility's landscape lights that highlight the south entry monuments. The south section of Shipley's Crossing four lights appears to be in good condition and operational. The lights were on at the time of our site visit and need to be adjusted for correct timing.

- Adjusting Light Angles
 - Frequency: Quarterly
 - What to Do: Adjust the angles of the lights to ensure they are properly highlighting the monuments. Make sure the lighting is even and covers the entire area.

- Testing Timers and Sensors
 - Frequency: Quarterly
 - What to Test: Test any timers or motion sensors to ensure they are functioning correctly. Adjust settings as needed to optimize lighting schedules.

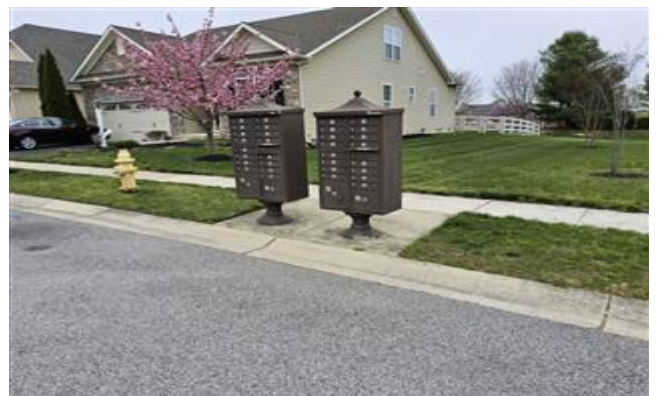
Mailboxes. The South Shipley's Landing Community has four ornamental community cluster mailboxes which appear to be in good condition.
